**A PHASE I  
ENVIRONMENTAL SITE ASSESSMENT**

1.48-Acre Safeway/American Legion Property  
1153 Duane Street and 1132 Exchange Street  
Astoria, Oregon

January 17, 2003

Hahn and Associates, Inc.  
Portland, Oregon

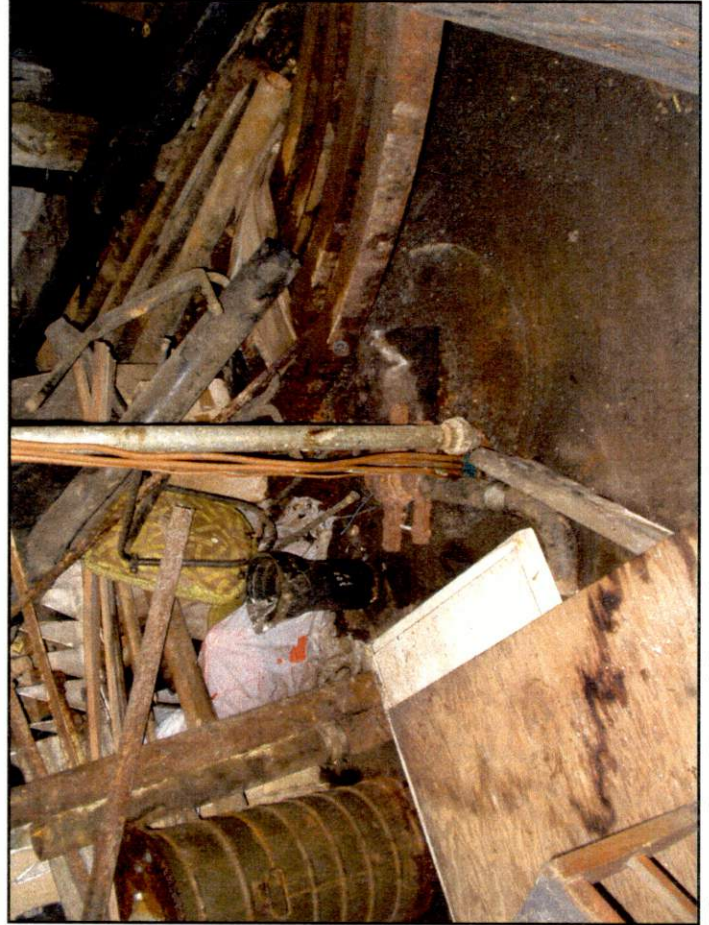
A manhole and piping for a reported heating oil UST (Photograph 3) were observed in the concrete floor in the accessible area beneath the Exchange Street sidewalk, adjacent to the basement area of the American Legion building. The presumed fill cap for this UST was also observed, at street level, in the Exchange Street sidewalk (Photograph 4). According to Mr. Ruzick, the heating oil UST supplied an oil furnace formerly used to heat the property structure. Mr. Ruzick estimated that the heating oil UST has not been used since approximately the 1960s, at which time the property structure converted to natural gas for heat. He was unaware of whether or not any product remained in the UST.

Photograph 3: View of the underground heating oil tank manhole and piping located beneath the Exchange Street sidewalk (January 3, 2003).

**Recommendation:** The heating oil underground storage tank associated with the American Legion building should be decommissioned in accordance with all applicable regulations. Soil sampling should be performed beneath each end of the tank to determine if a release has occurred and the decommissioning certified by a Licensed Heating Oil Tank Service Provider. Additionally, the concrete box should be investigated to verify the presence or absence of a tank within. If a tank is found within the concrete, it should be decommissioned and soil sampling should be performed beneath each end of the tank to determine if a release has occurred. Likewise, if this tank is determined to be an underground heating oil tank, the decommissioning should be certified by a Licensed Heating Oil Tank Service Provider.

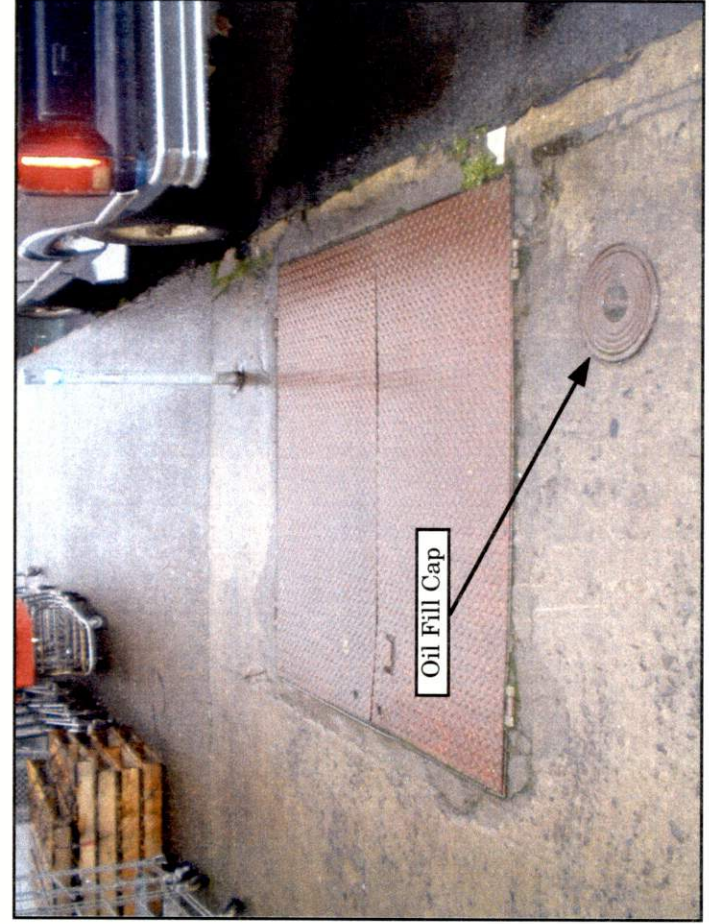
A manhole, piping, and a fill port, associated with a reported heating oil tank, were observed at and below street level at the Exchange Street sidewalk to the south of the American Legion building. The heating oil tank has reportedly not been used since approximately the 1960s, when the property structure was converted to natural gas heat.

Photograph 4: View of the oil fill cap in the Exchange Street sidewalk, located to the south of the American Legion building (January 3, 2002).

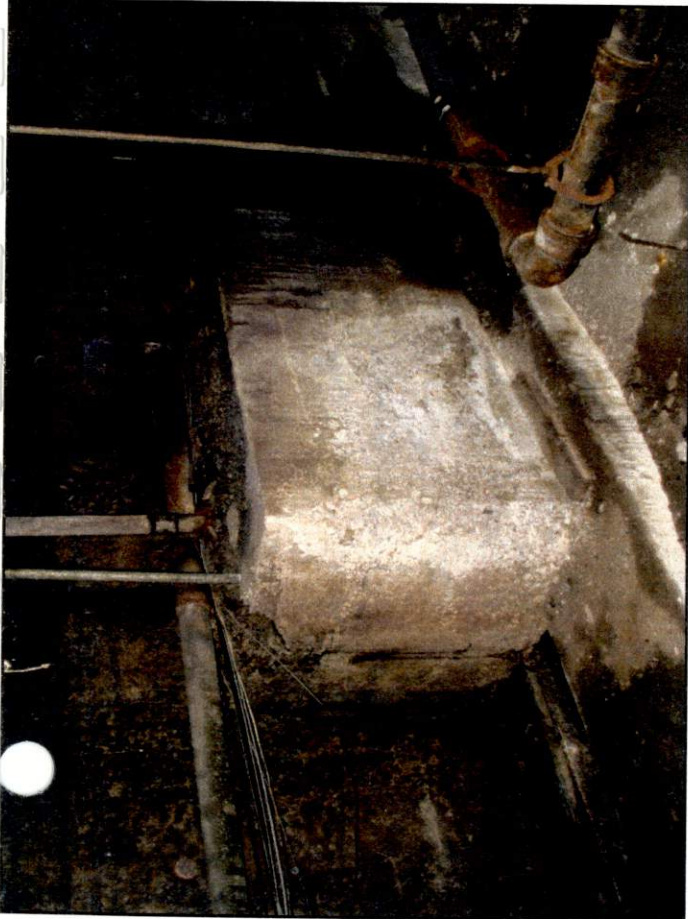
A concrete box with approximate dimensions of 3 feet by 3 feet by 6 feet (Photograph 5) was observed beneath the Exchange Street sidewalk in the area to the south of the Safeway store. Pipes emerging from the top of the concrete box indicated that a tank may have been encased within. It is possible that a heating oil tank, which may have historically been used to heat the Safeway store or a former property structure, is situated within the concrete casing. It is unclear as to whether the suspect tank would be considered an UST or an AST. An oil fill cap possibly associated with this potential tank was observed aboveground in the Exchange Street sidewalk (Photograph 6), in an area to the south of the Safeway store loading dock. No other ASTs were observed on the property.

Photograph 5: View of the concrete box and extruding piping located beneath the Exchange Street sidewalk (January 3, 2003).

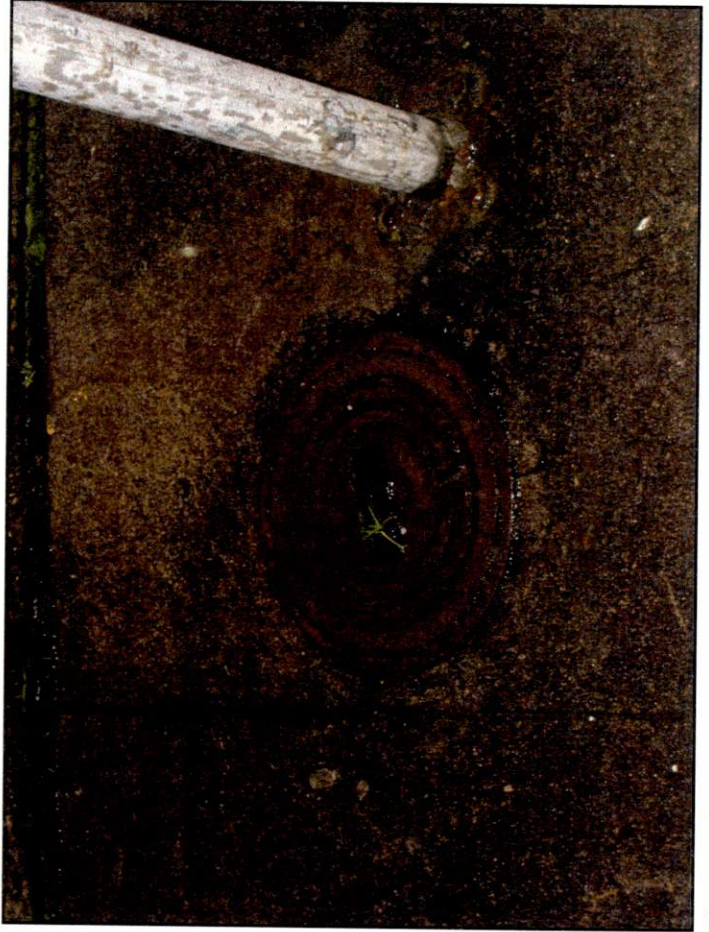
A concrete box with extruding piping was also observed beneath the Exchange Street sidewalk adjacent to the property, in the area to the south of the Safeway store. It is possible that a heating oil tank, which may have historically been used to heat the Safeway store or a former property structure, is situated within the concrete casing. An oil fill cap, possibly associated with this potential tank, was observed at street level in the Exchange Street sidewalk. It is unclear as to whether the suspect tank would be considered an underground storage tank or an above-ground storage tank.

Photograph 6: View of the oil fill cap in the Exchange Street sidewalk located to the south of the Safeway store's receiving ramp (January 3, 2003).

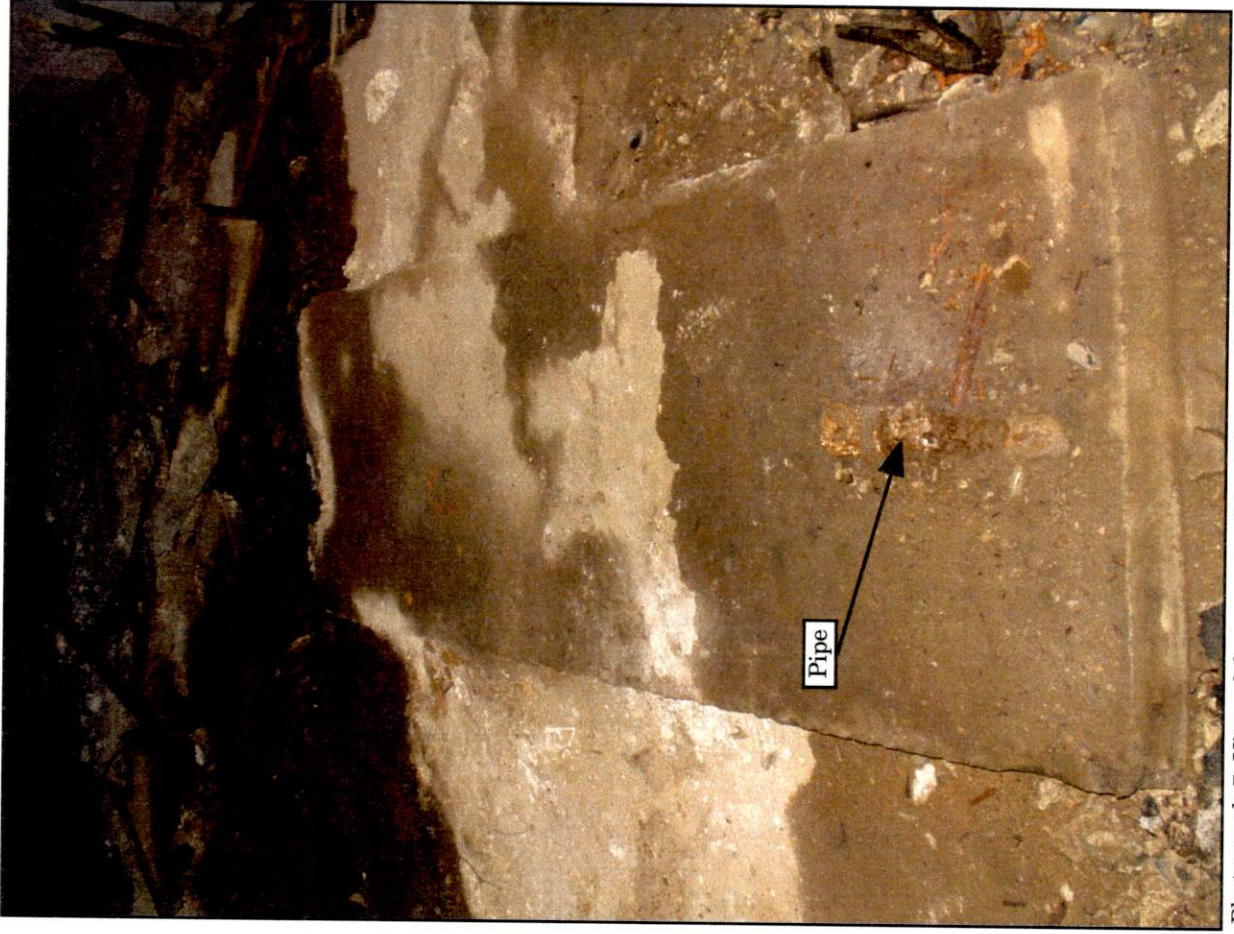
In addition, a concrete slab (Photograph 7) was observed below the surface grade near the Exchange Street sidewalk at the property's southern perimeter. The slab was approximately 3 feet wide, 8 feet long, and 5 inches thick. A rusted metal pipe extruded from the concrete at one end of the slab, indicating that something (possibly an UST) may be located beneath the slab.

Photograph 7: View of the concrete slab with one extruding pipe, located below ground in the area to the south of the Safeway store (January 3, 2003).

**Recommendation:** A geophysical survey should be performed at the property to identify the potential presence of underground storage tanks at the concrete slab and to the north of the Safeway store. If an underground tanks are found, they should be decommissioned in accordance with all applicable requirements. Further, a subsurface investigation should be performed to the north of the Safeway store, due to the indicated use of "gas and oil" in this area, regardless of whether an underground storage tank(s) is found in this area.
