APPENDIX 1: TECHNICAL MEMOS

Structural: Conditions Assessment

Architectural: Conditions Assessment

01 | EXECUTIVE SUMMARY

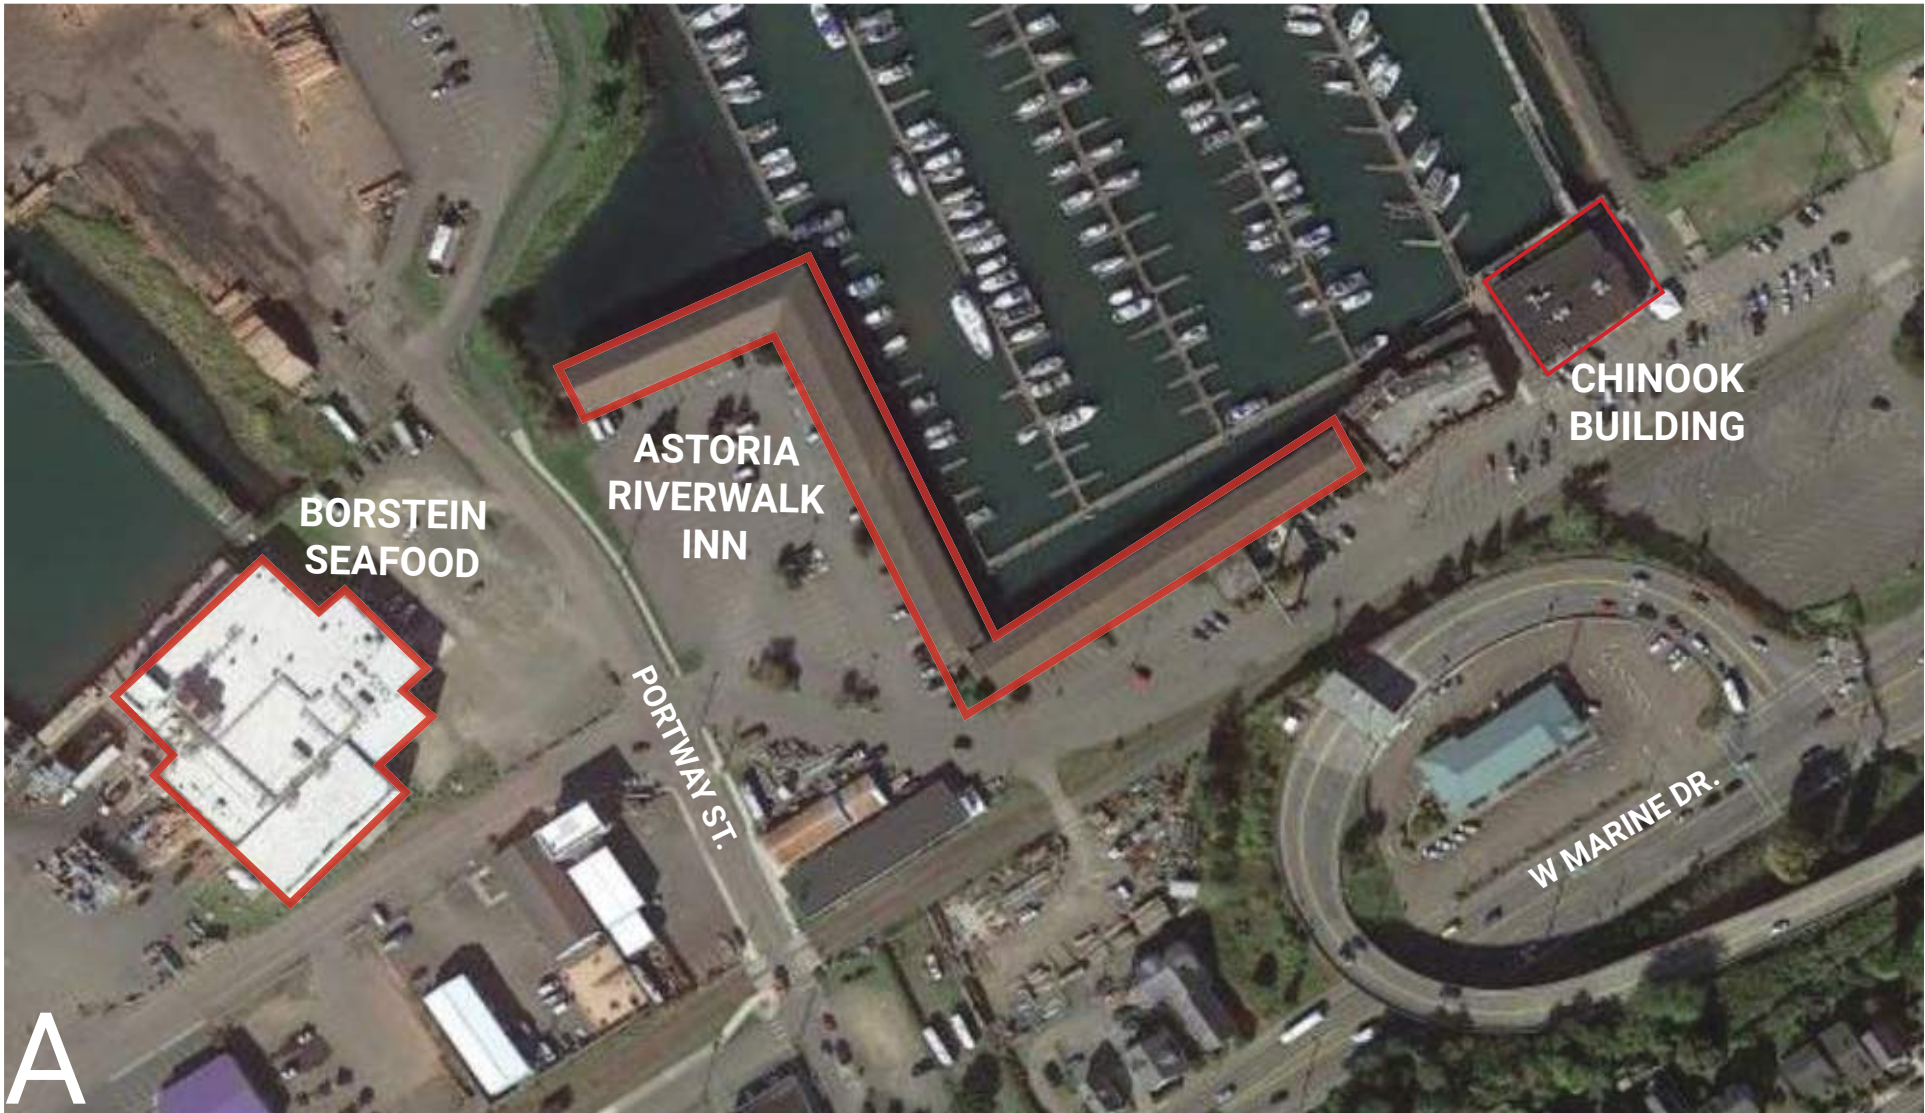
A: Building locations within the existing conditions assessment report.

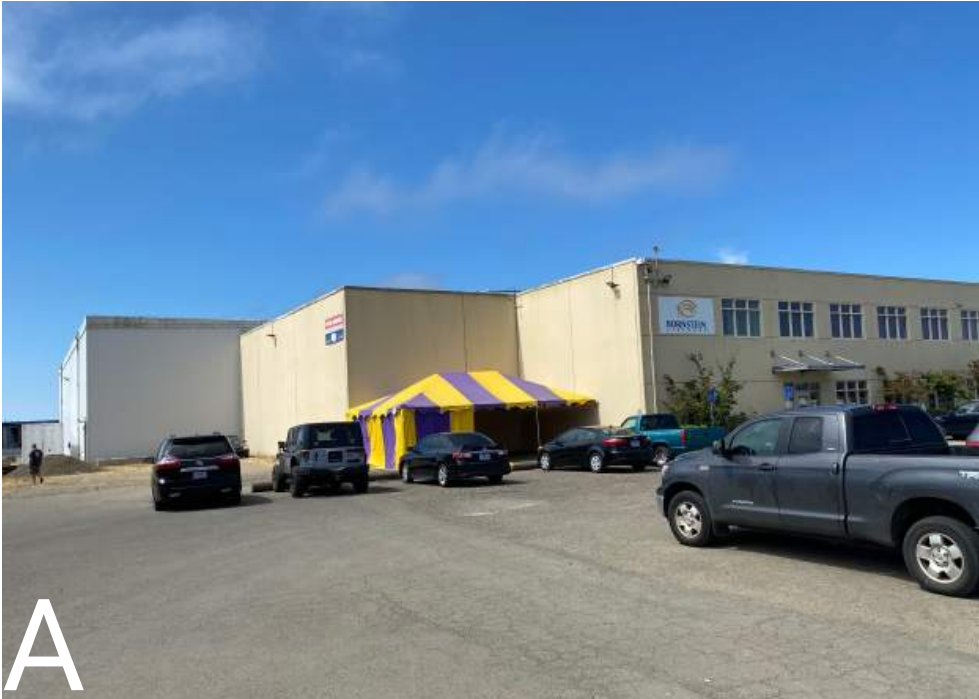
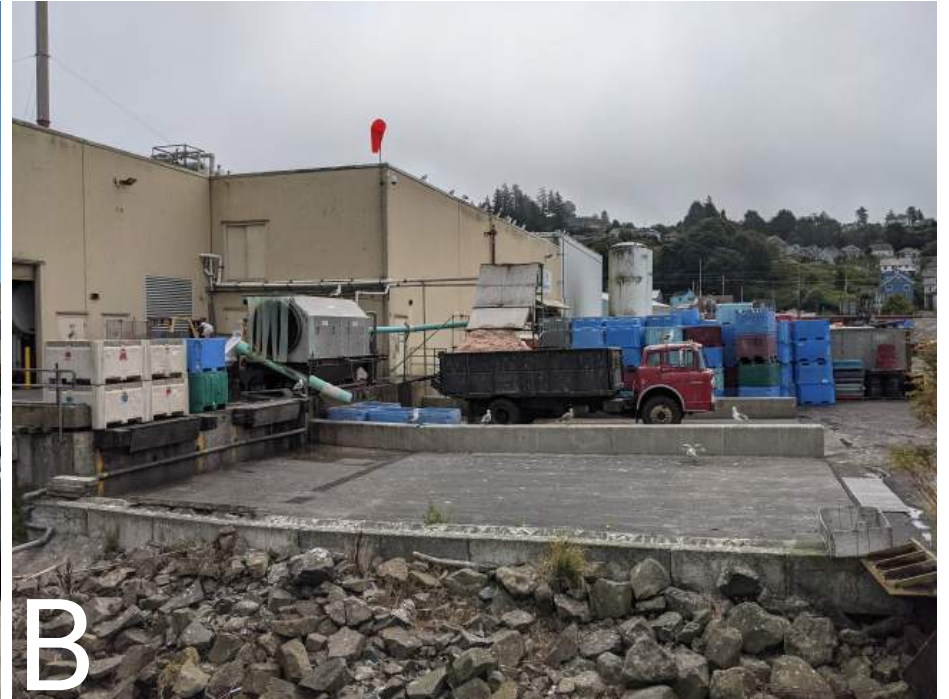
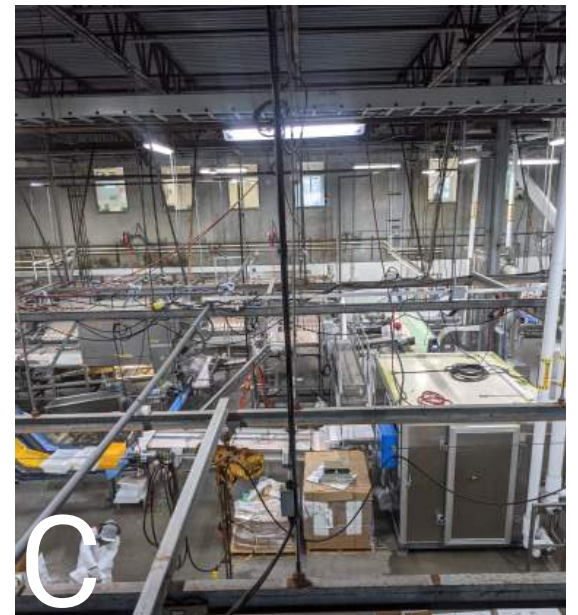
A: East elevation Bornstein main entrance
B: North West corner service area for the seafood waste process and loading
C: Elevated walk way overlooking seafood processing.

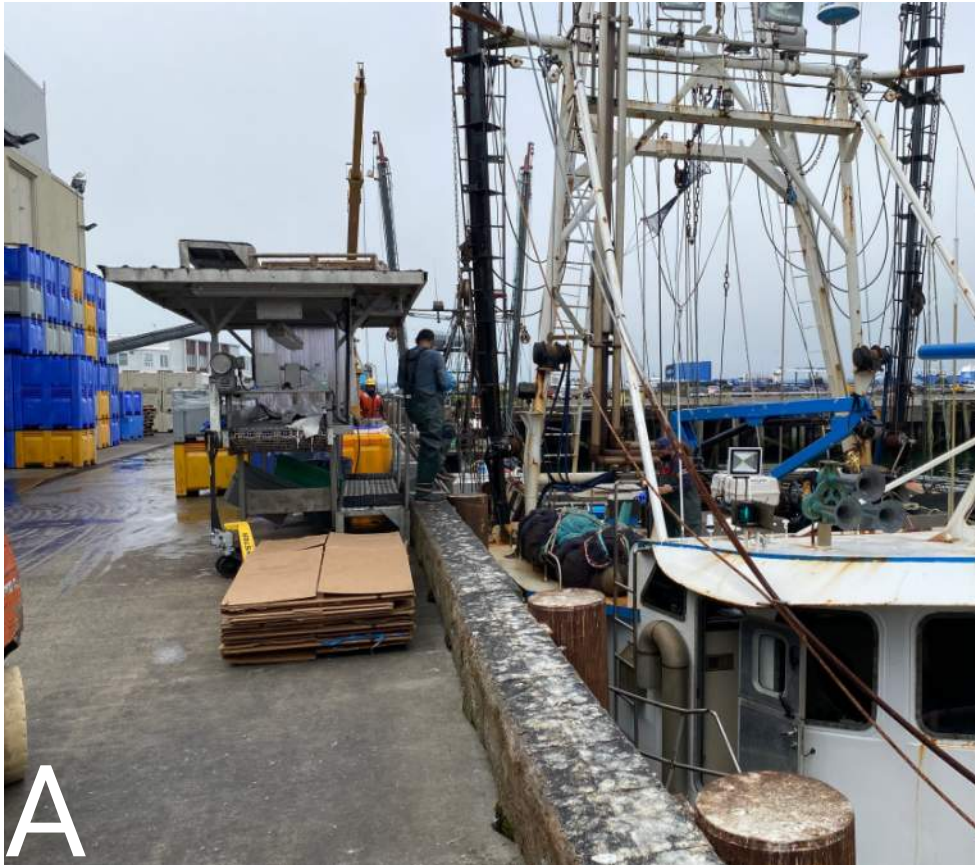
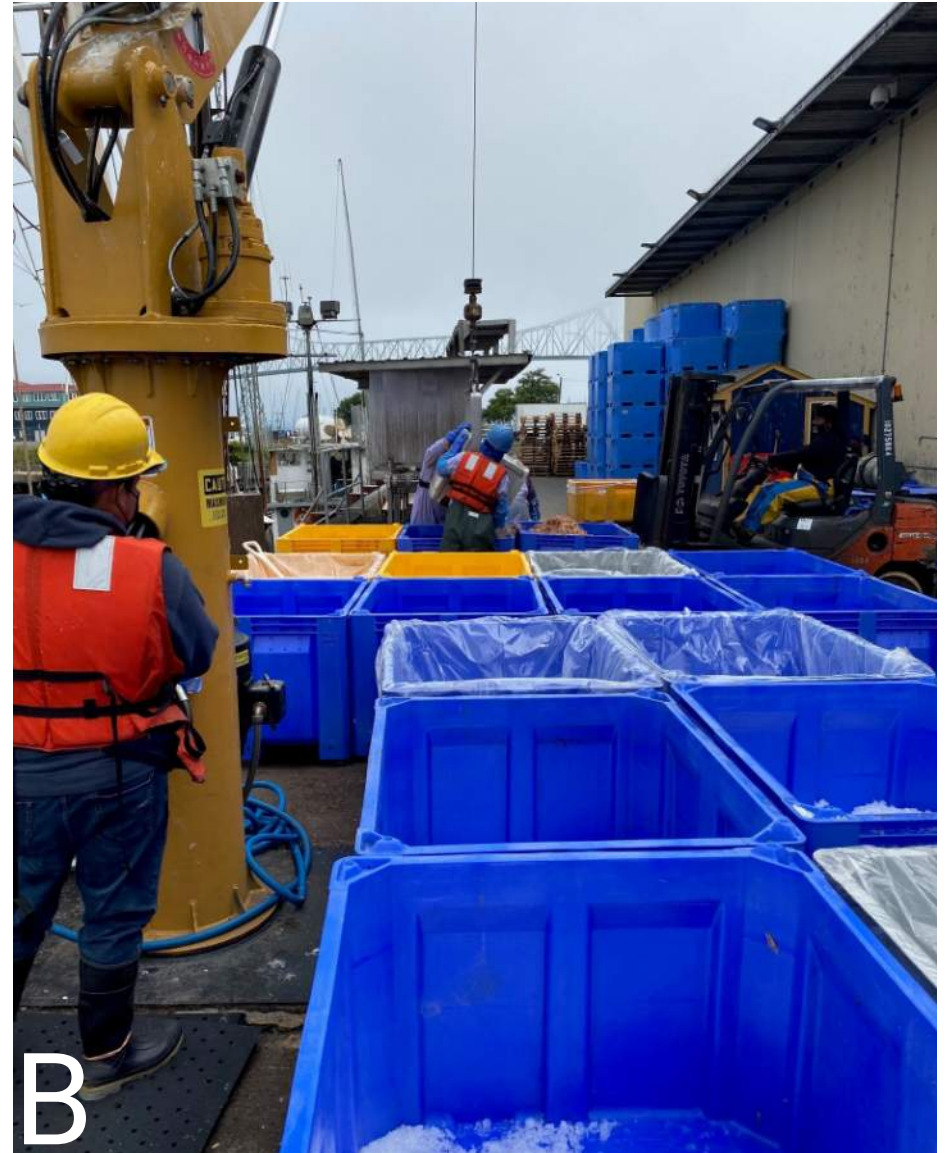
A: North Dock, boats unloading shrimp and reloading with ice to head back out to sea.
B: North Dock, Bornstein infrastructure to load and unload seafood from boats and into the processing plant.

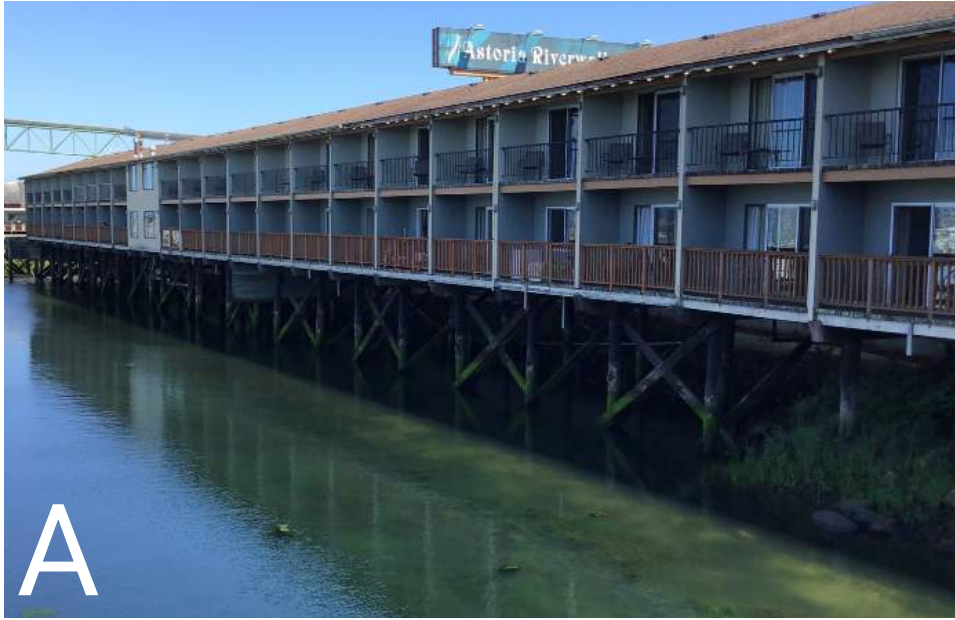
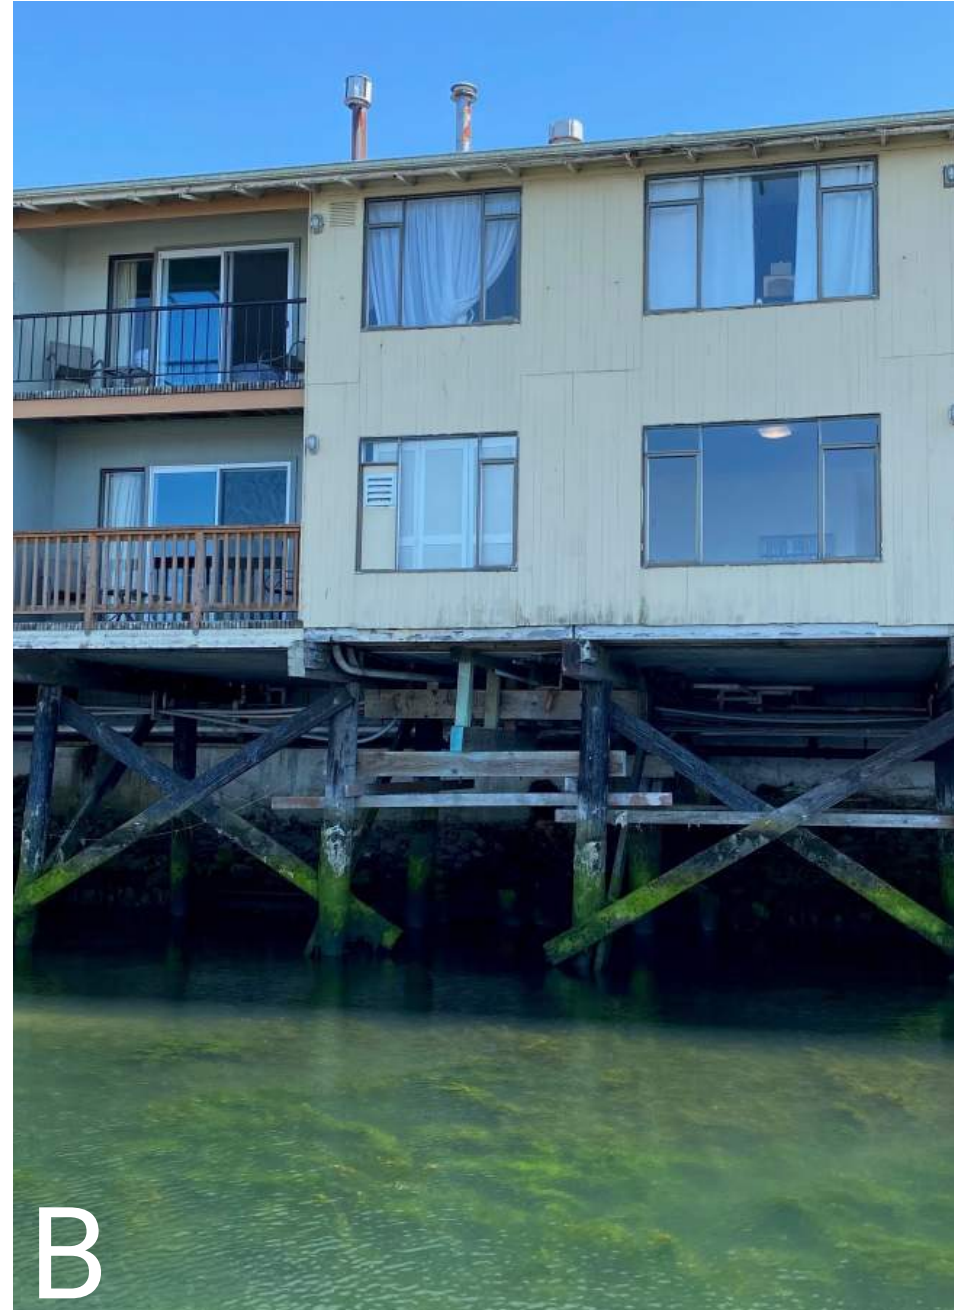
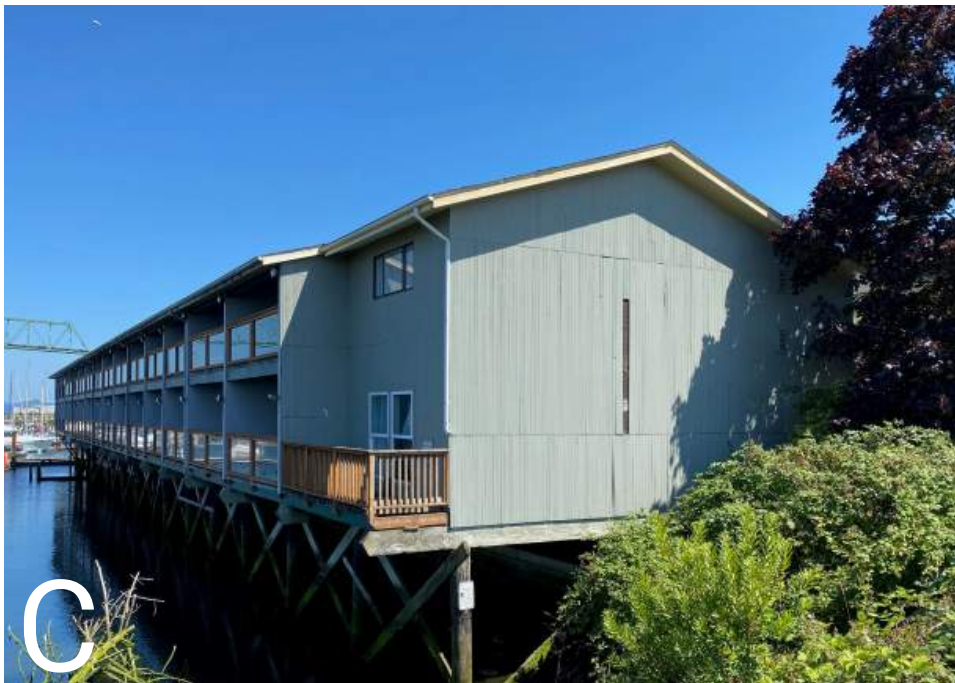
A: The original 56 unit built in 1972, showing large portions of gutters missing, decaying exposed structure, failing paint, and broken wood railings in many locations.
B: Laundry and office built over the water with signs of moisture and decay. Unsatisfactory repairs to the foundation pilings with unsecured and irregular timber layout.
C: West expansion showing missing siding, failing paint, and gutters that will cause moisture intrusion issues in the building envelope.

The motel provides a unique experience with every room having a water view. It is unclear if building a new structure over the water is viable under current code, and therefore a more extensive study is needed. One option would be to do a large renovation to maintain the viability of the site. Overhauling the support structure would be complicated and expensive, may be less costly to build a new structure, with the prospect of a new configuration along with adding new and more tailored program elements.

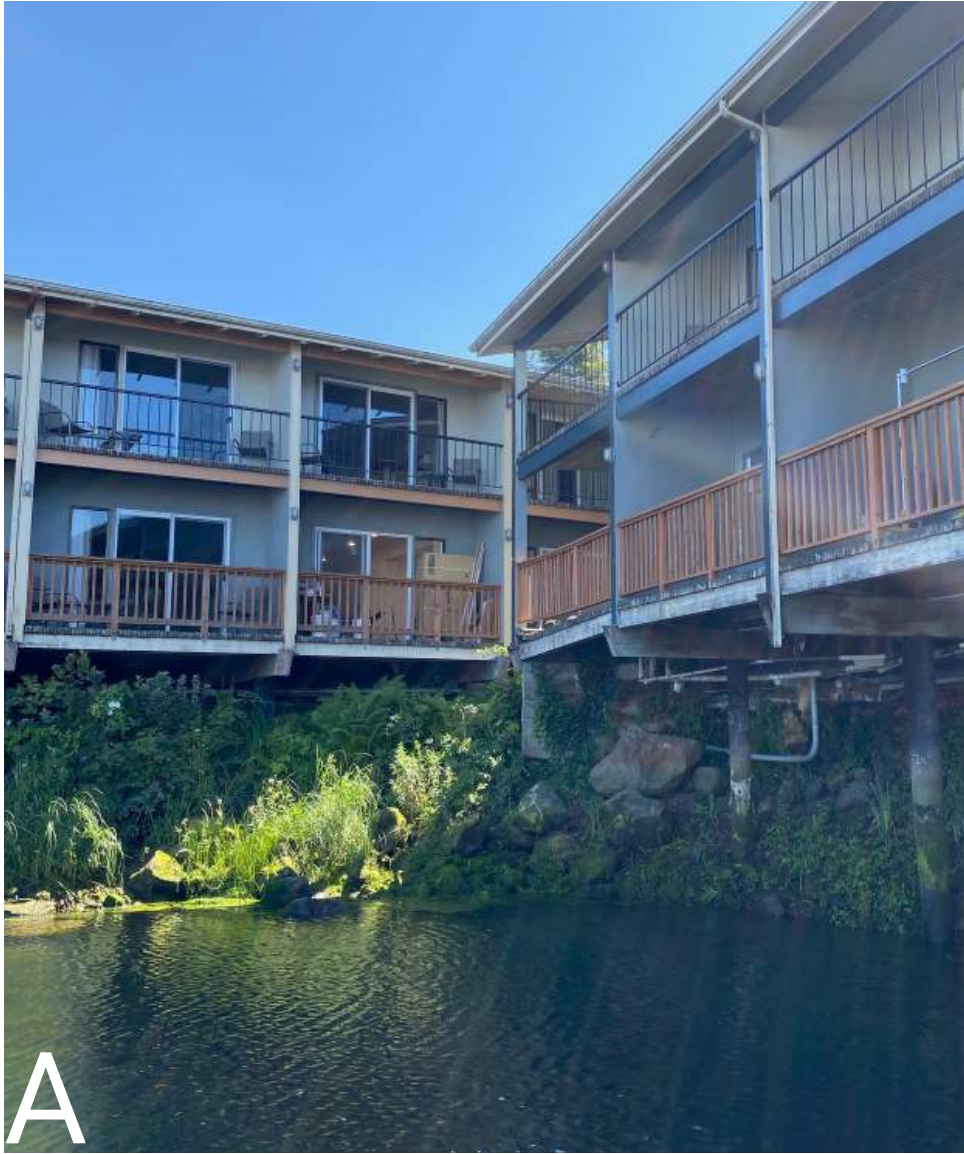
A: Foundation settlement has caused some rooms to be unsafe.

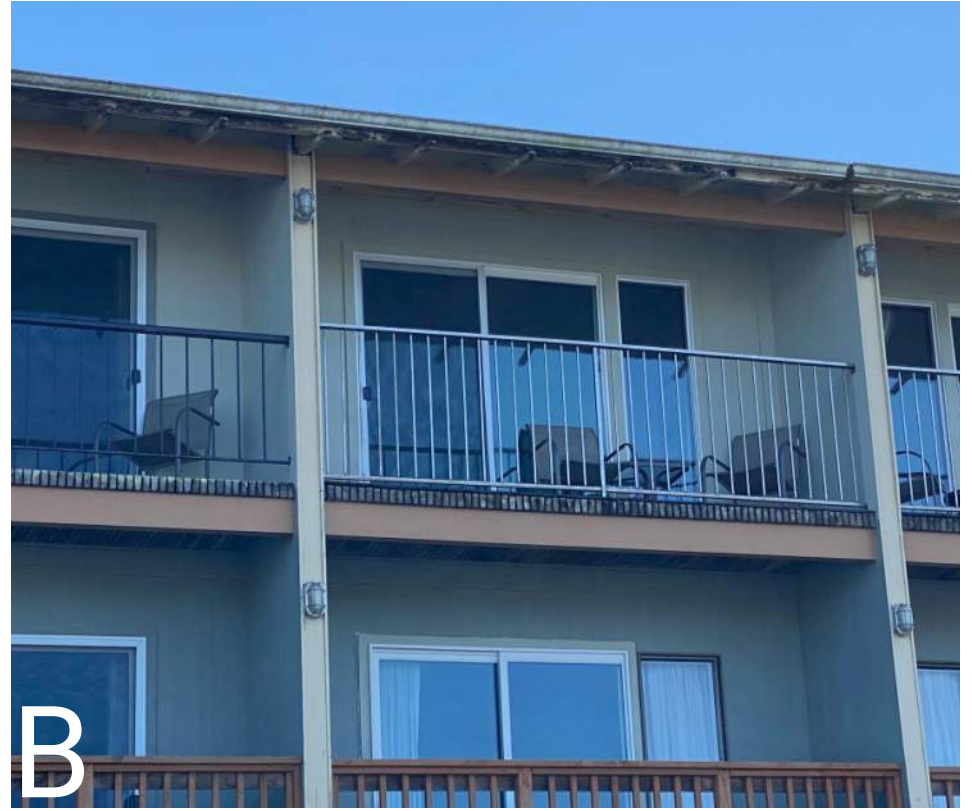
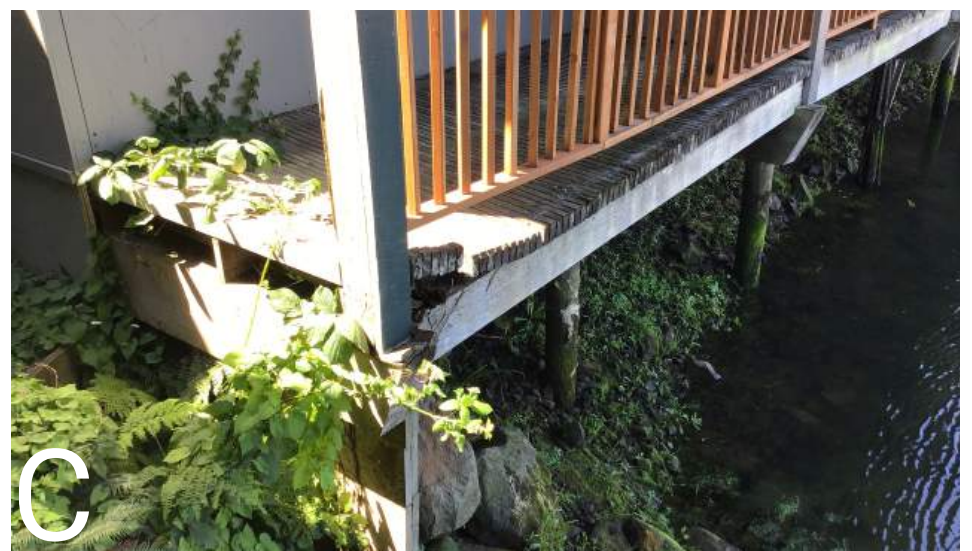
B

B: Large sections of fascia board and gutters are missing on the building causing large amounts of moisture issues and deteriorating railings.

This photo indicates three different railings for the balconys and different heights causing safety issues.

C: Foundation settlement has caused the balcony to be in an unsafe position.

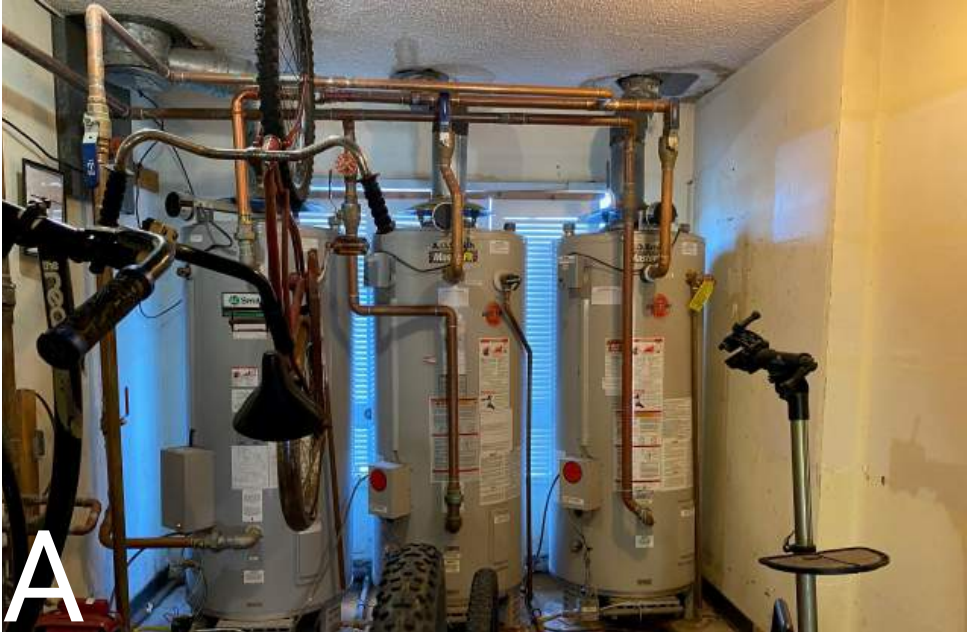
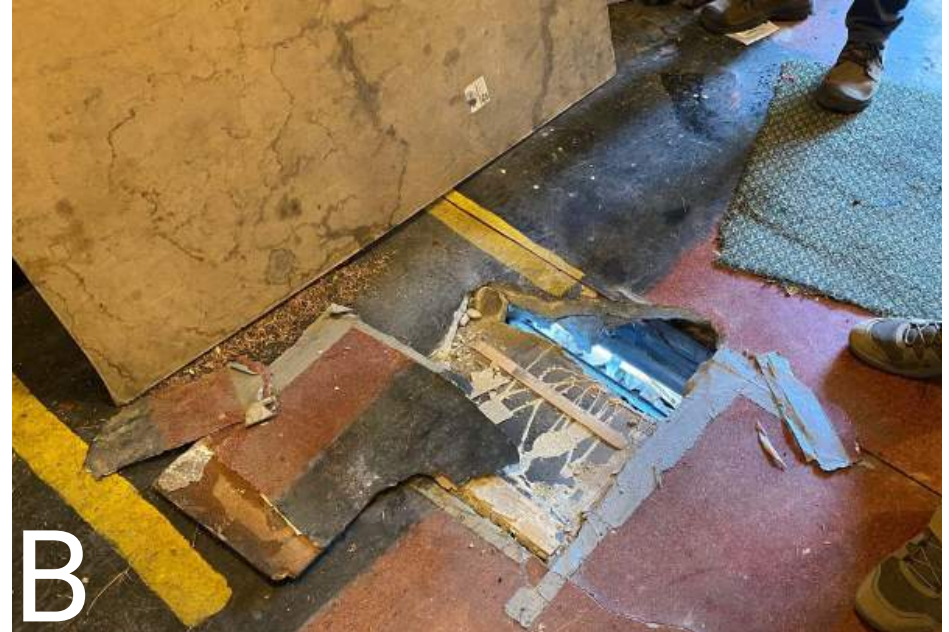
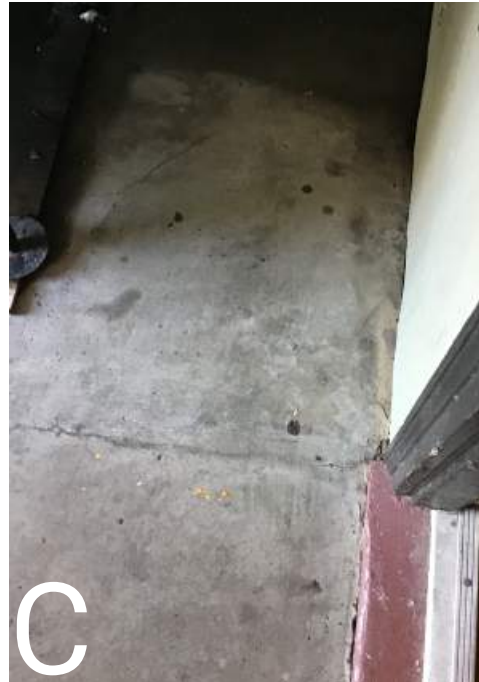
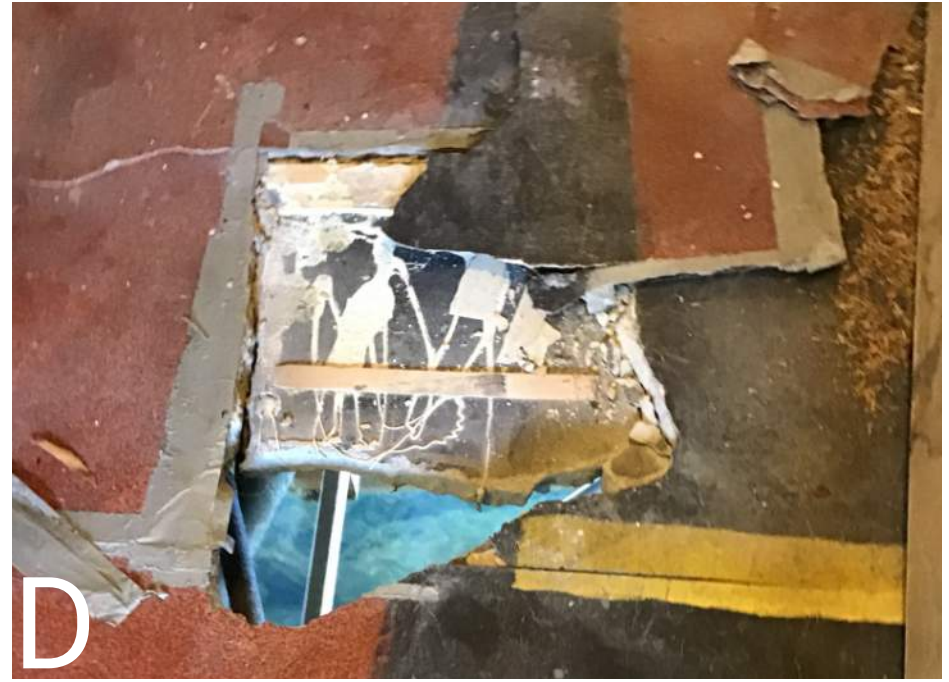
- A: Utility room has moisture issues and inadequate ventilation for the space.
- B: Hole in concrete floor exposed to the exterior below
- C: Settling concrete floor causing trip hazards at the door thresholds
- D: Floor material chipped away and crumbling around the exposed hole in the floor.

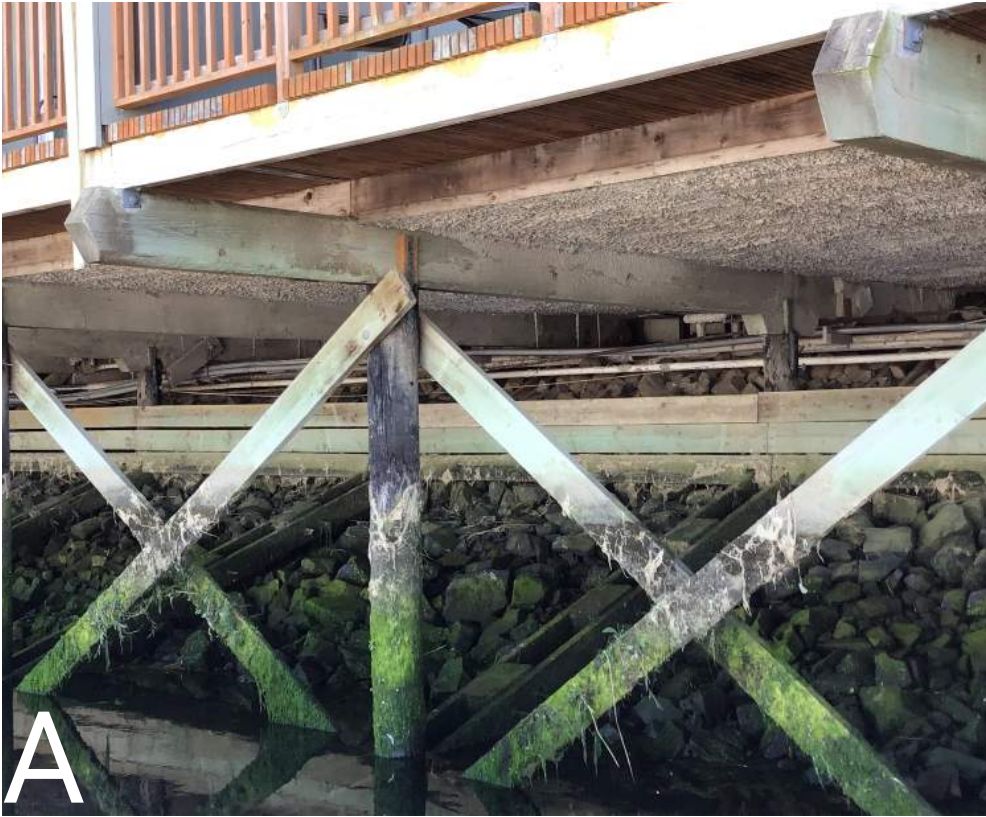
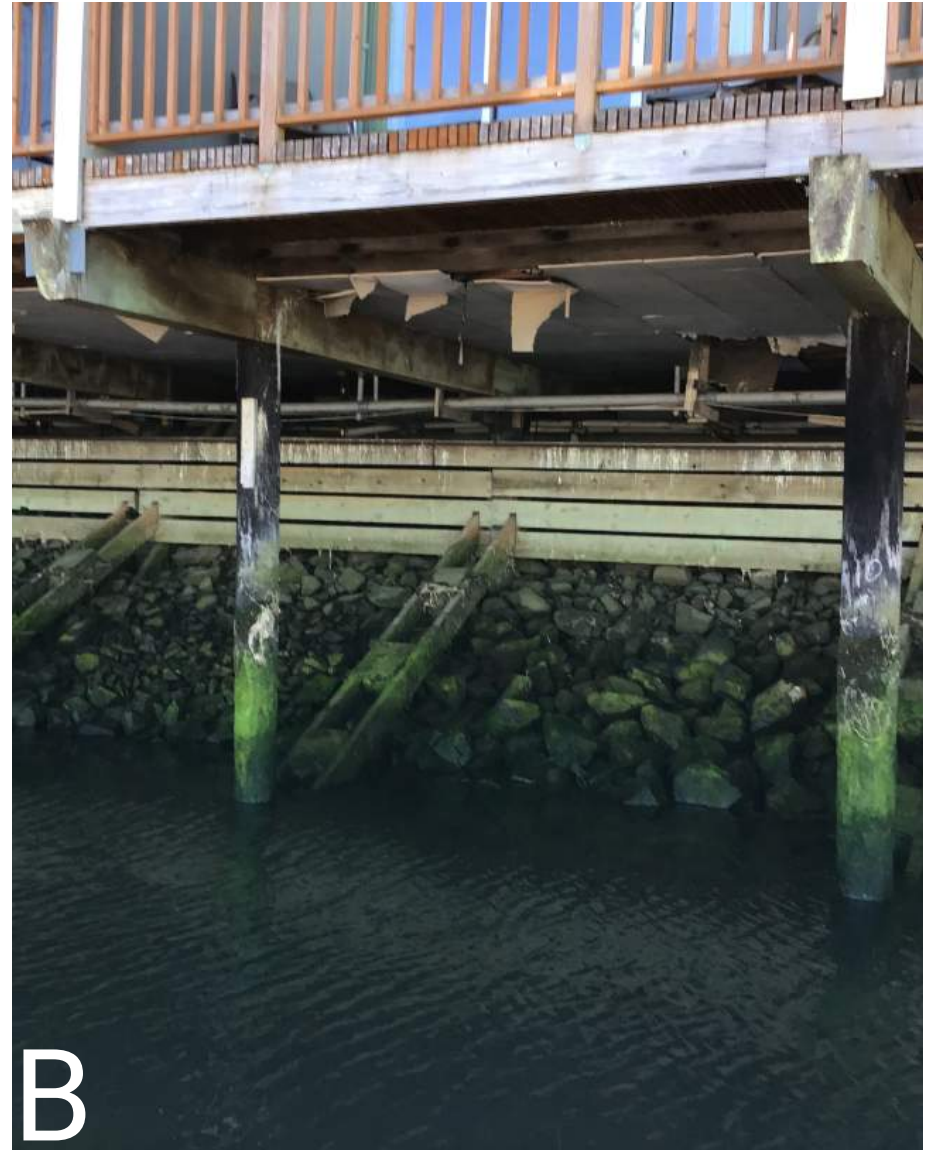
A: Piling and foundation structure has a mixture of new and old timber supporting the building; ceiling tiles are deteriorated, peeling apart and causing moisture intrusion on underside of the floor.
B: Pile foundation with marine growth evident and indications of newly replaced pressure treated beams above.

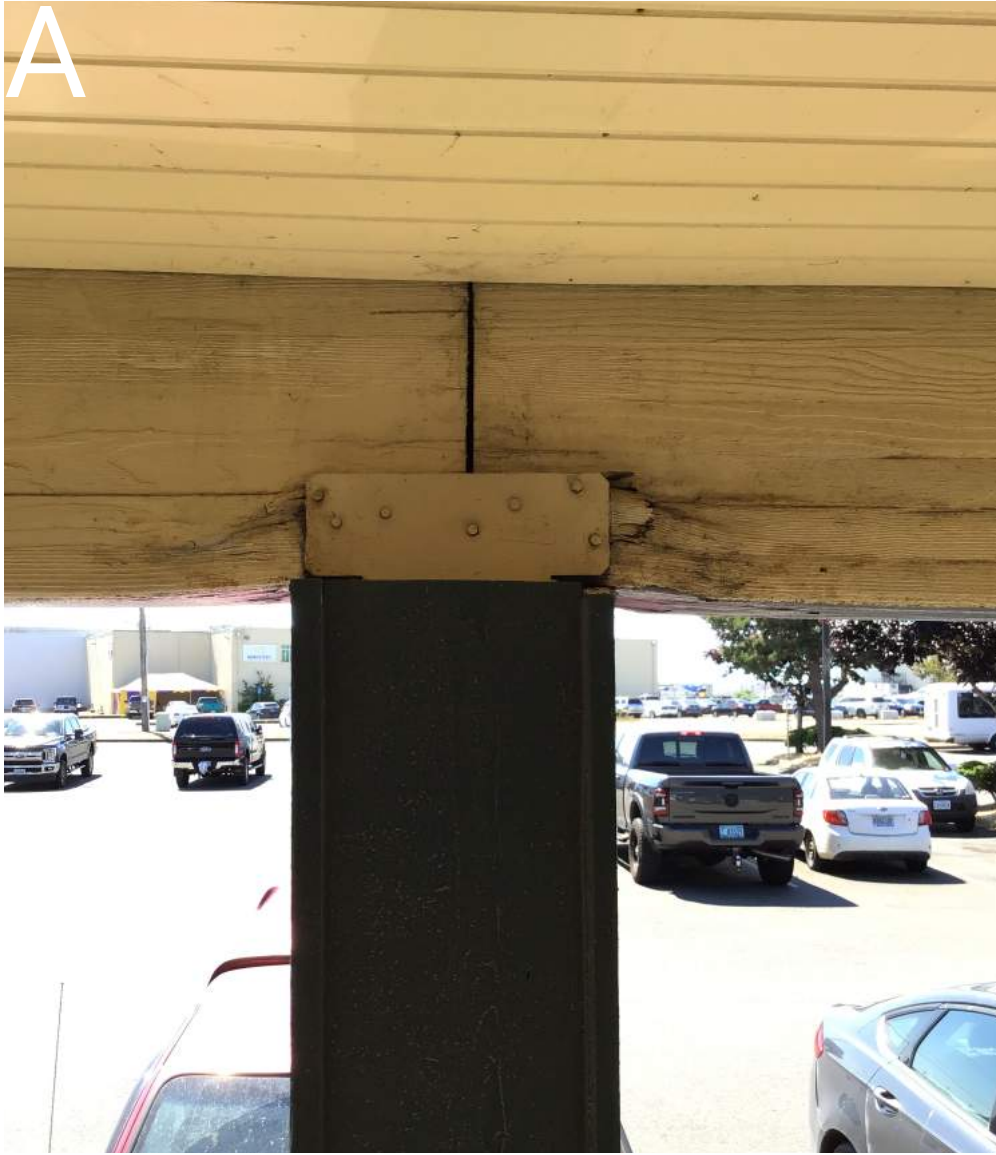
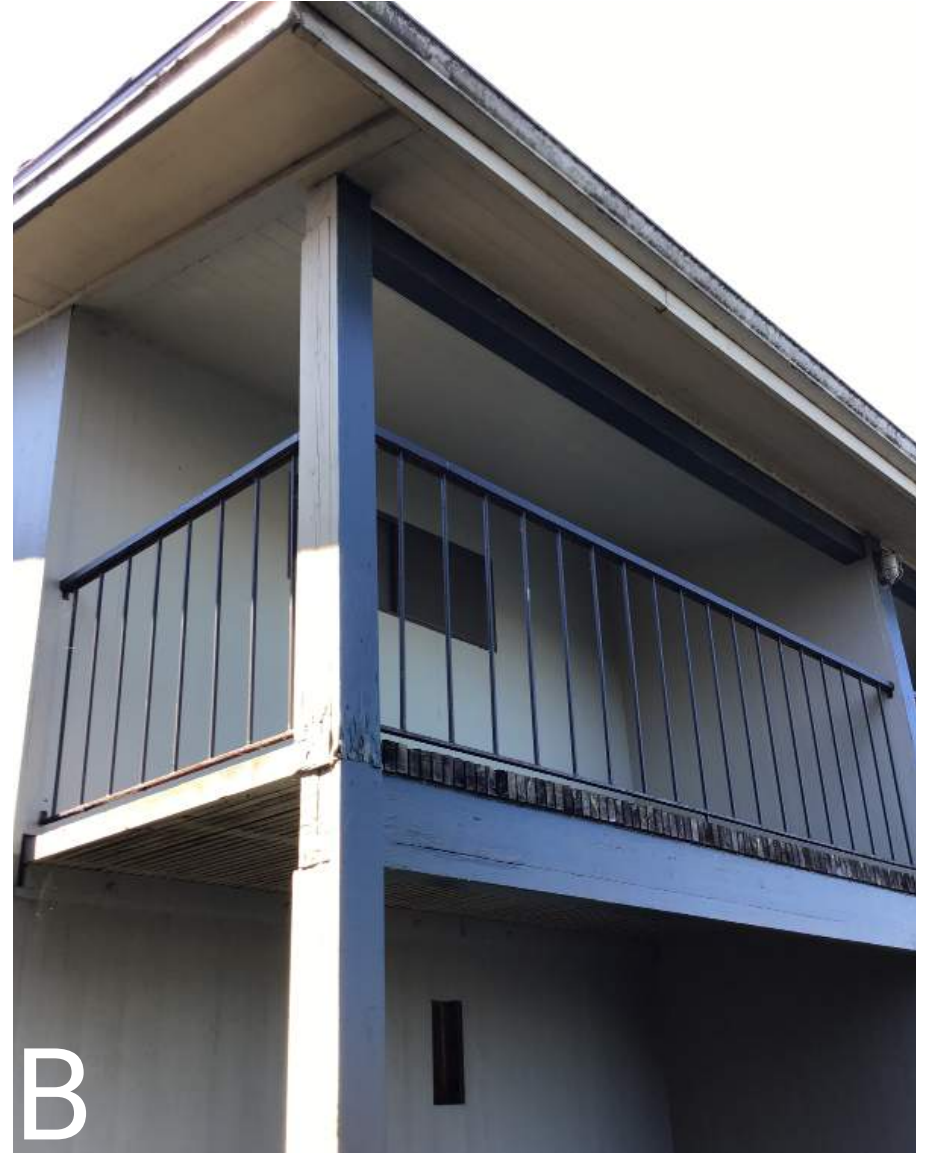
A: Visual beam decay and crushed wood fiber at the primary metal connection
B: Visual corner column decay at beam and porch connection

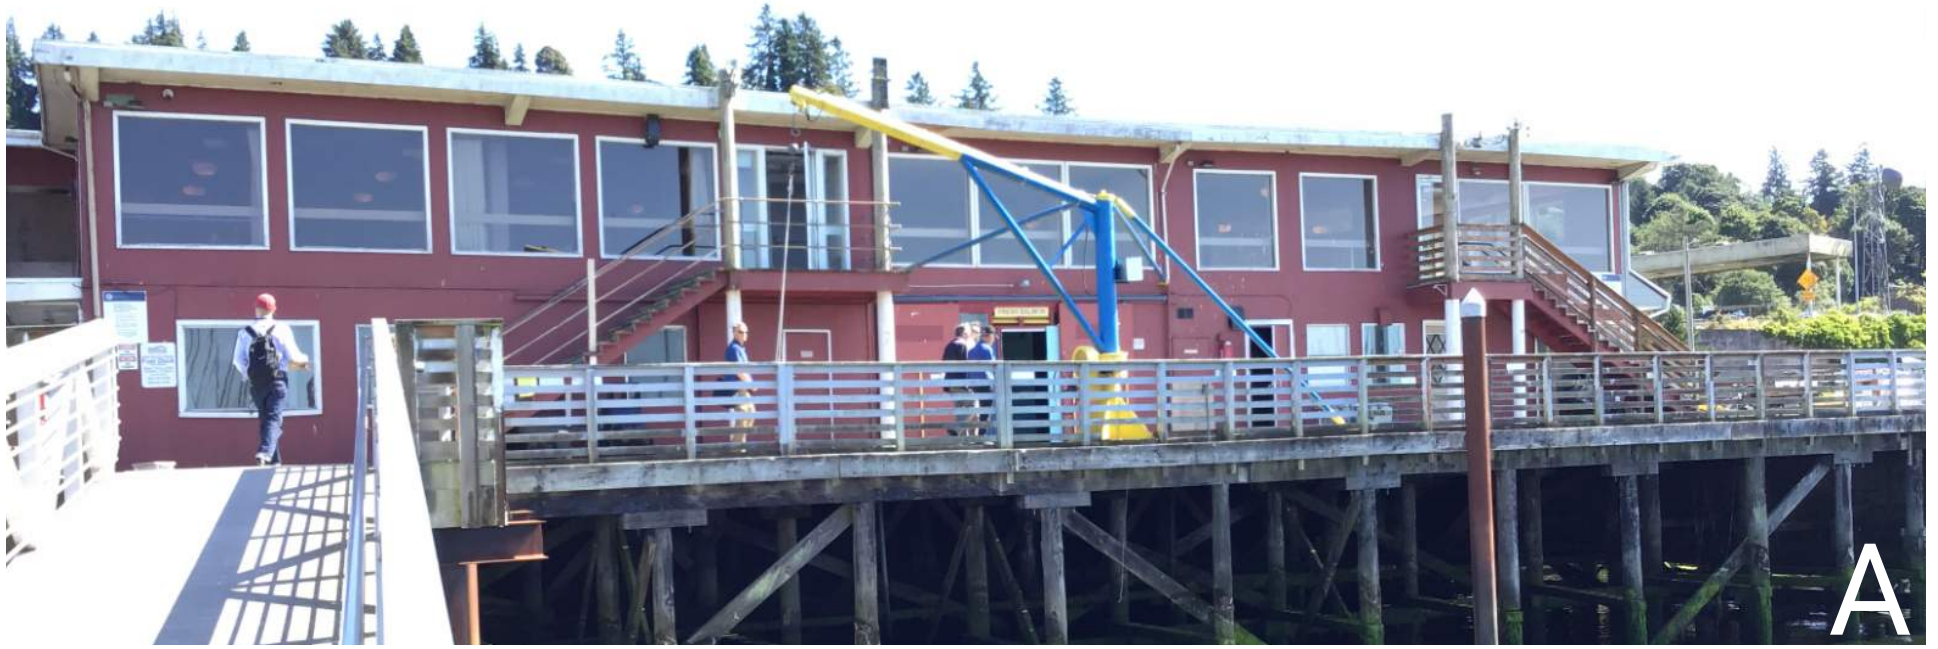
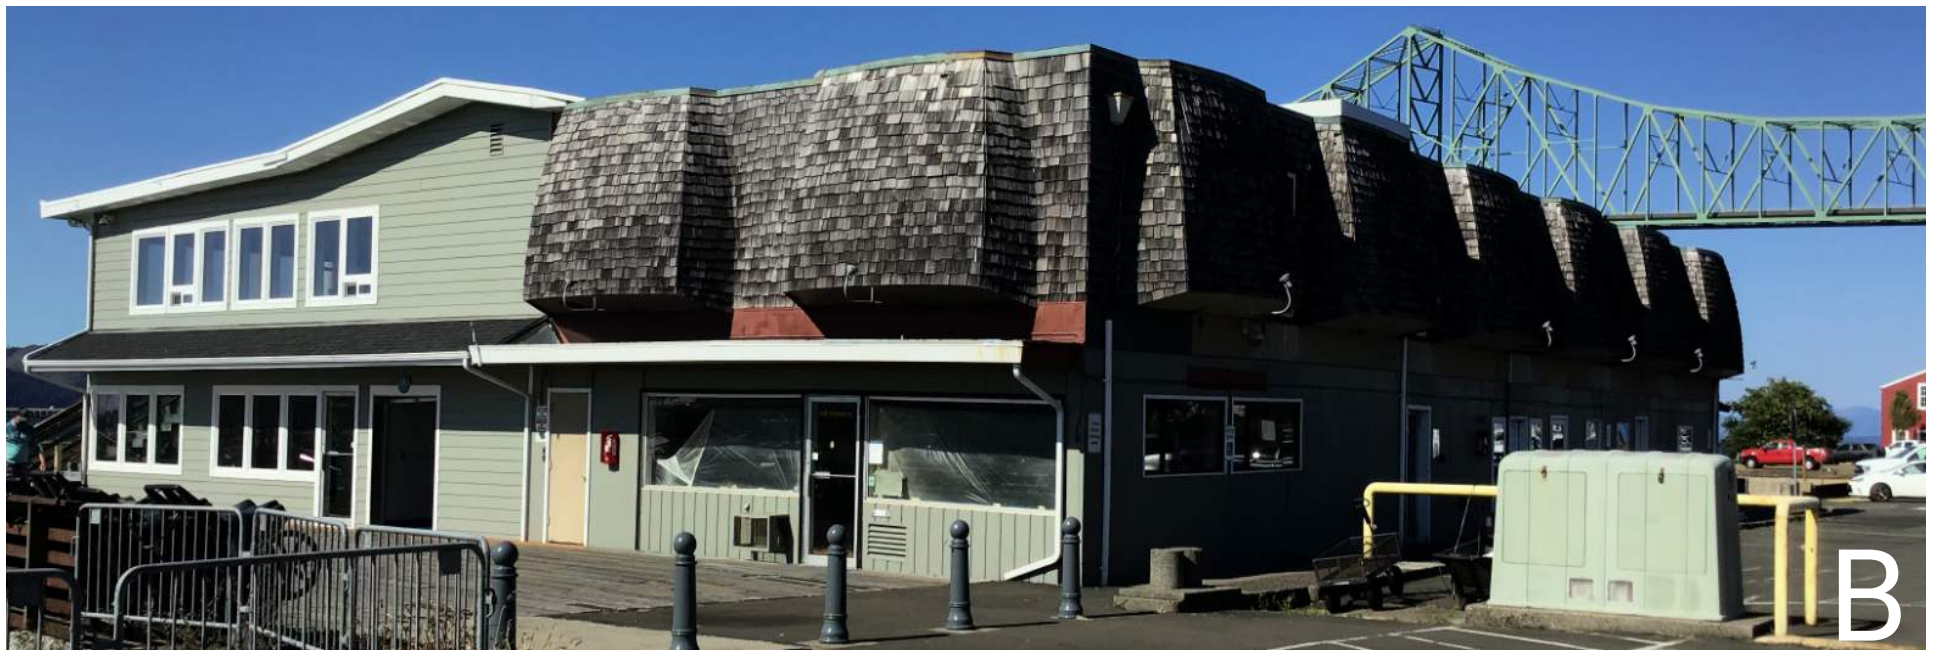
A: West elevation over the water with crane to unload fishing boats and equipment.
B: South elevation (left) shows 1980s construction removed and rehabilitated, (right) is 1980s renovations showing deteriorated gutters, flashing, and drip edges that help to keep the building envelope dry.

The building would likely require extensive renovations, and at this point it could be less expensive to demolish the current building and build new rather than work around the poor existing conditions. Like the Riverwalk Inn, it is unclear if building a new structure over the water is possible under current code, and therefore a more extensive study is needed. A new structure would allow for alternative program elements with a greater range of possible uses aimed at the needs of the community.

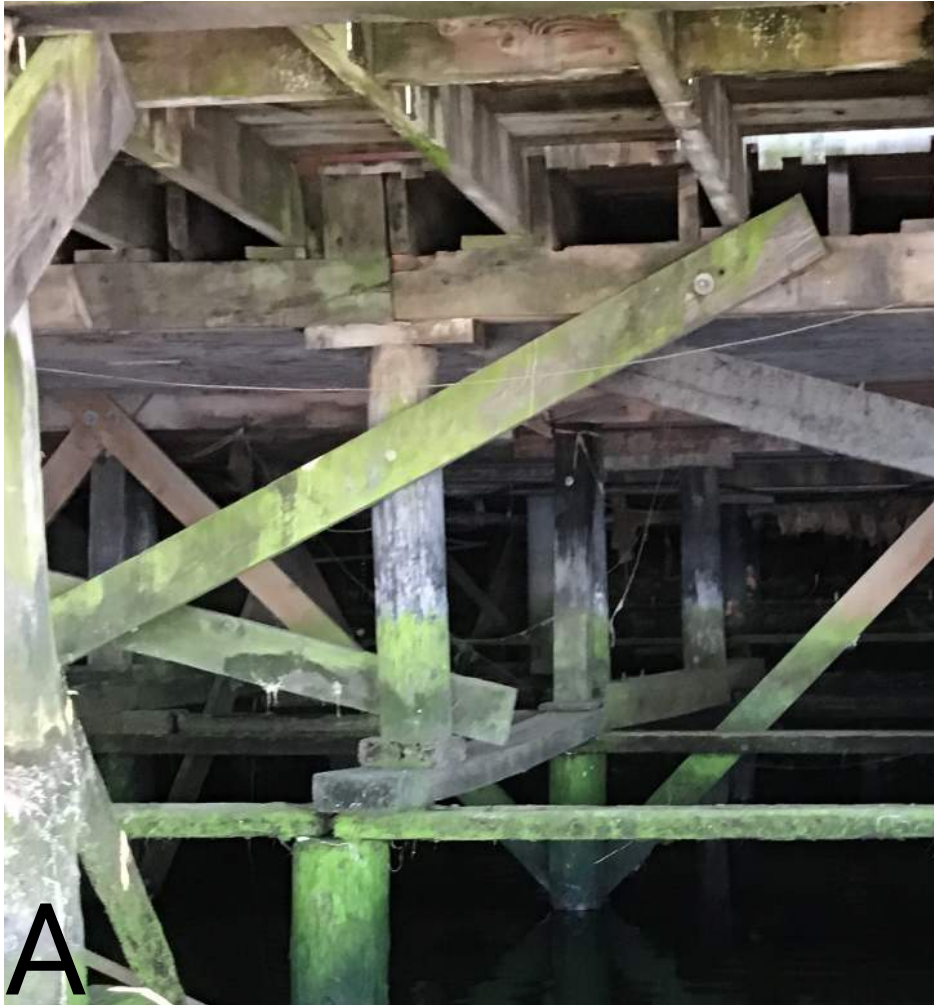
A: Pier foundation elements indicate possible failures in many locations.

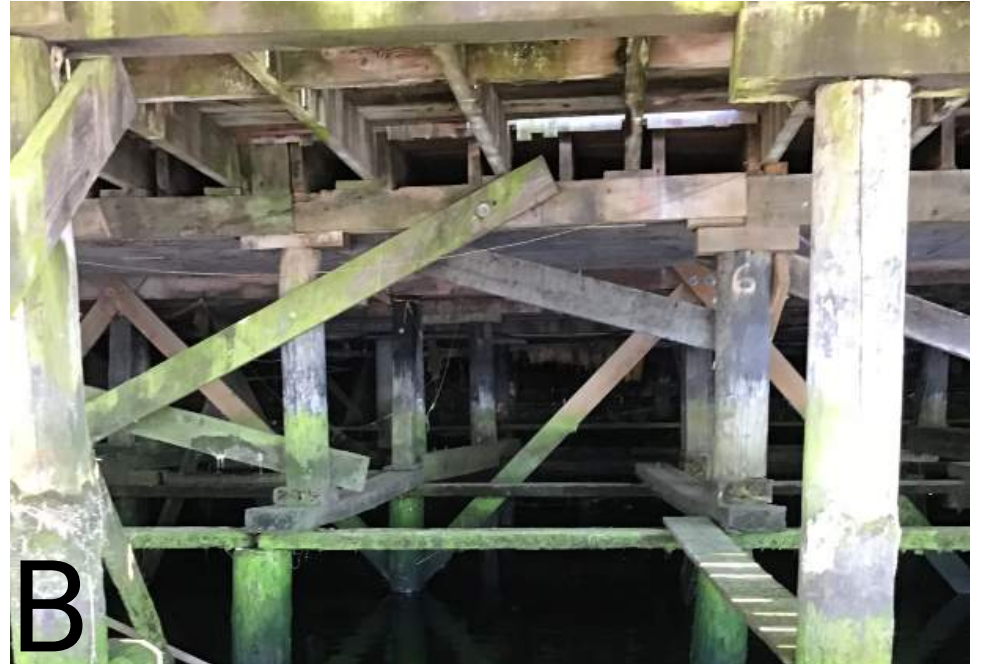
B: Decaying pier foundation under the Chinook building, some areas do not have continuous load paths to piles with minimal connections.

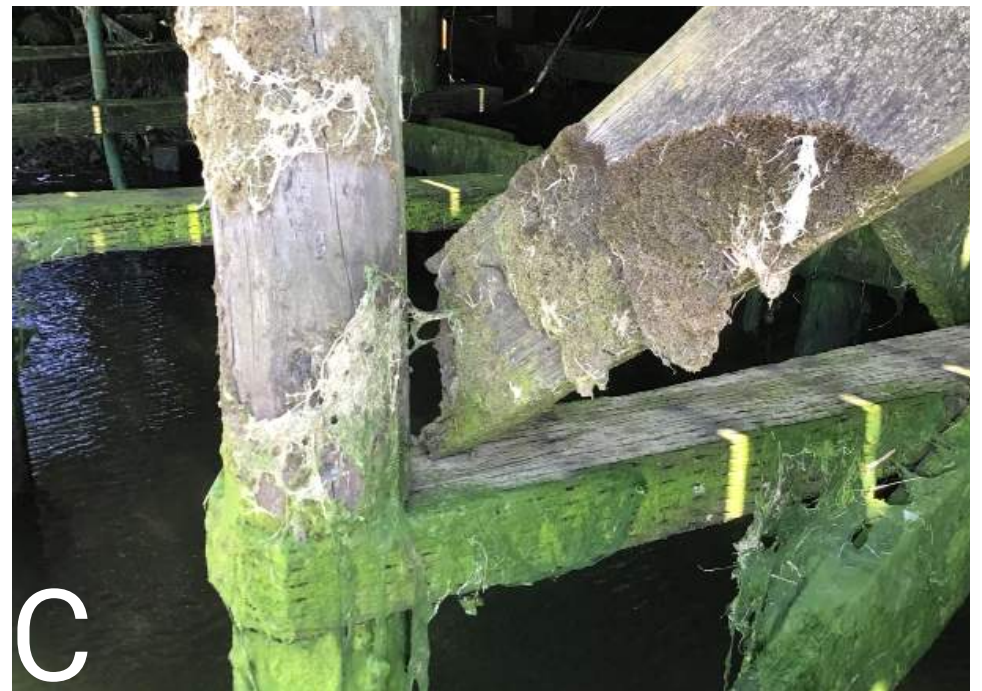
C: Visual decaying pile foundation with cross bracing fully detached is an example of long term deferred maintenance and decay
