APPENDIX 1: TECHNICAL MEMOS

Structural: Conditions Assessment

Architectural: Conditions Assessment

01 | EXECUTIVE SUMMARY

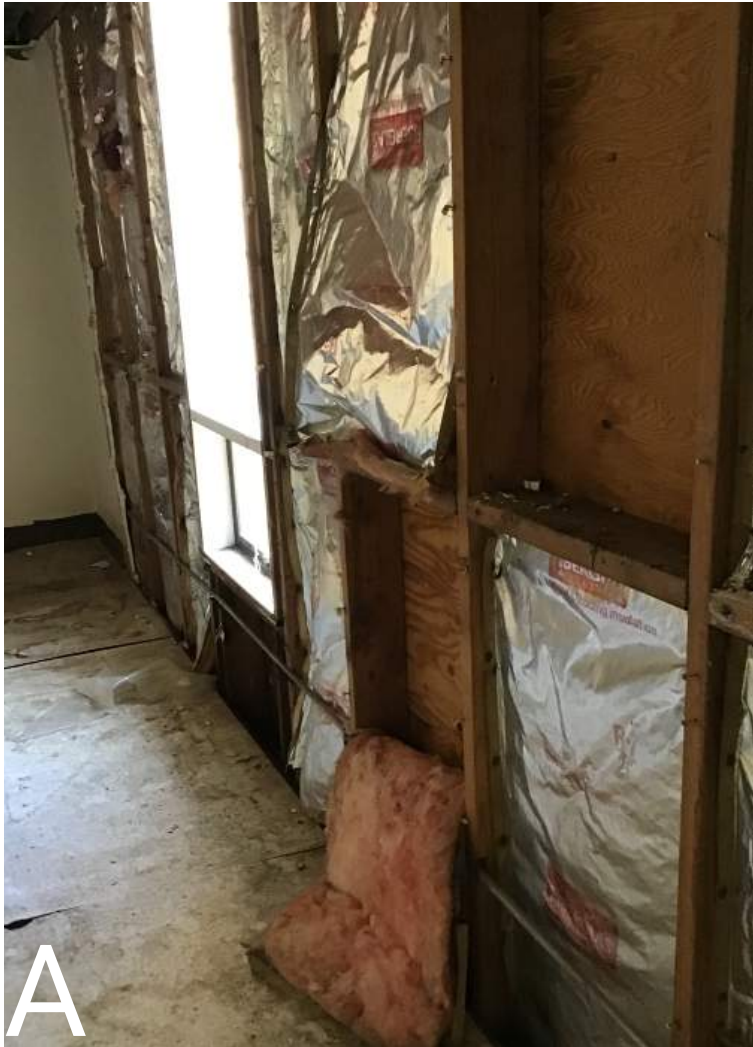
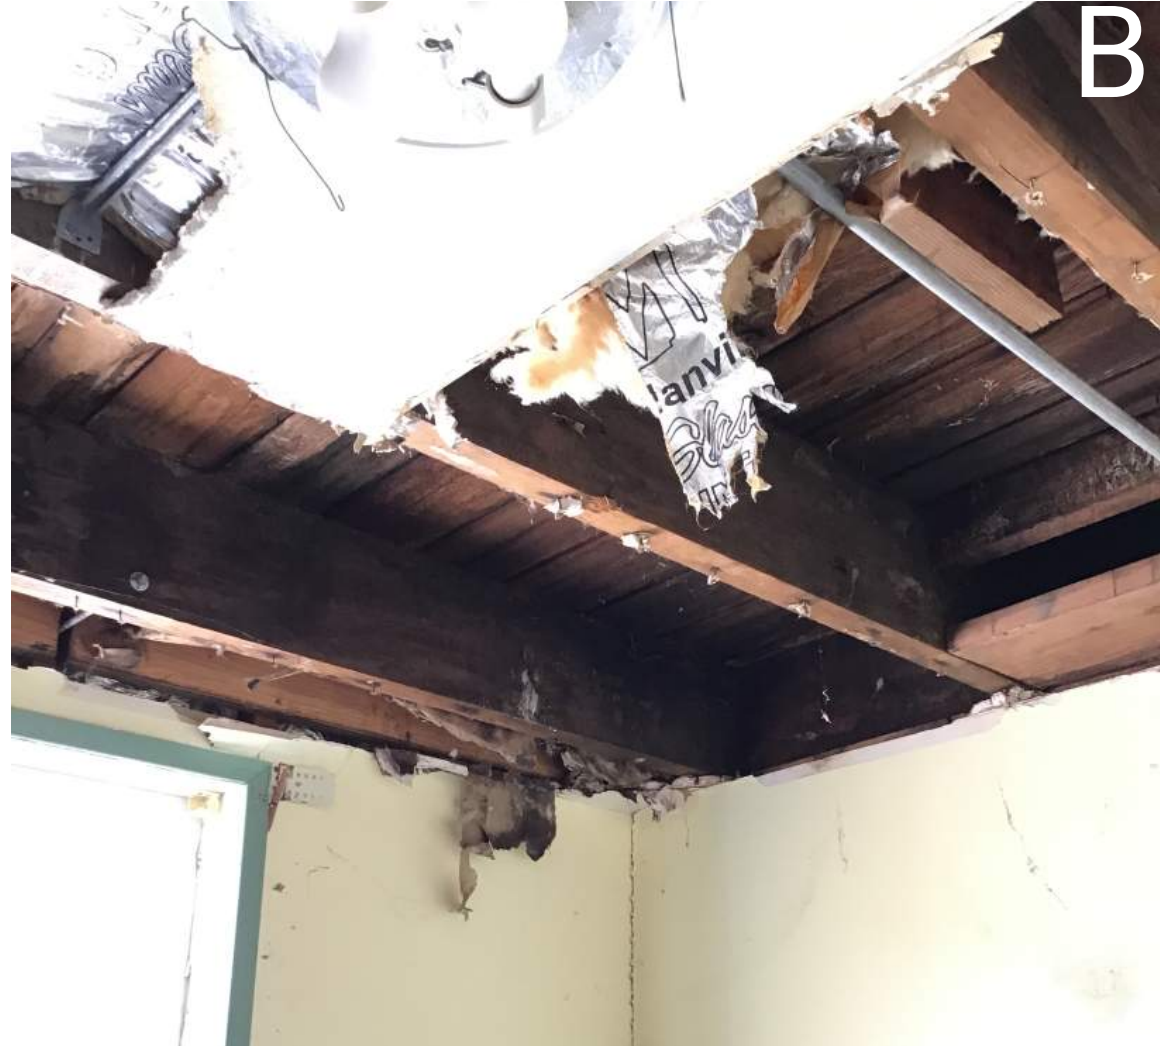
A: Typical wall construction (2x4 walls 24" O.C. with Fiberglass batt insulation)
B: Typical roof construction (2x12 joists 24" O.C. with Fiberglass batt insulation)

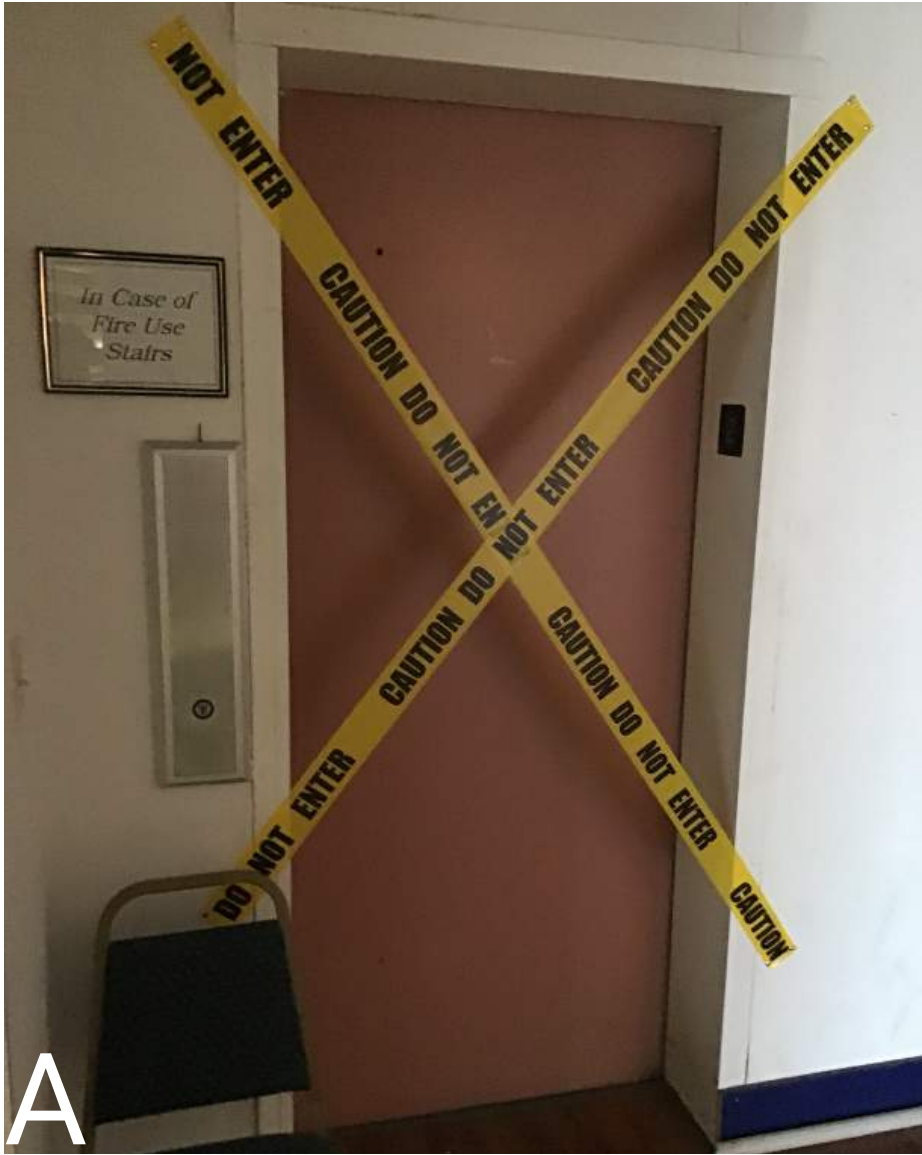
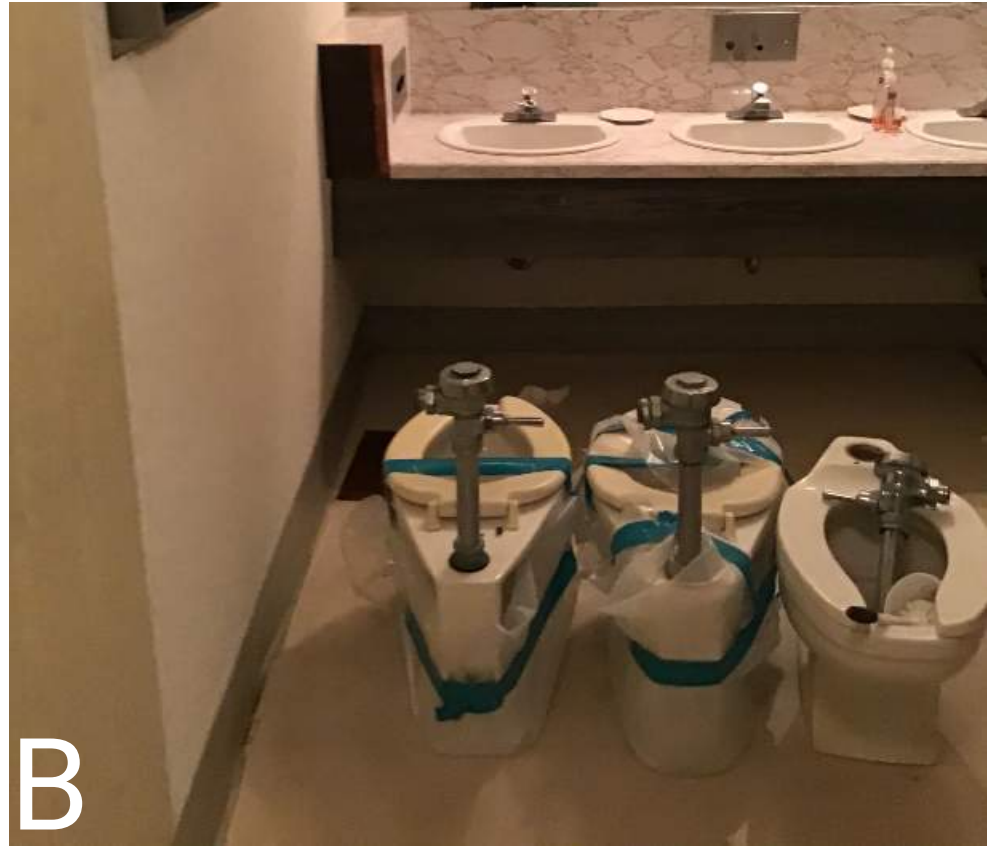
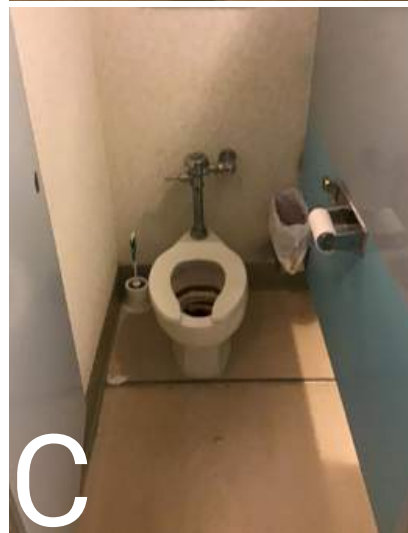
A: Nonoperational elevator
B: Bathroom in disrepair with failing fixtures
C: Typical Bathroom stall

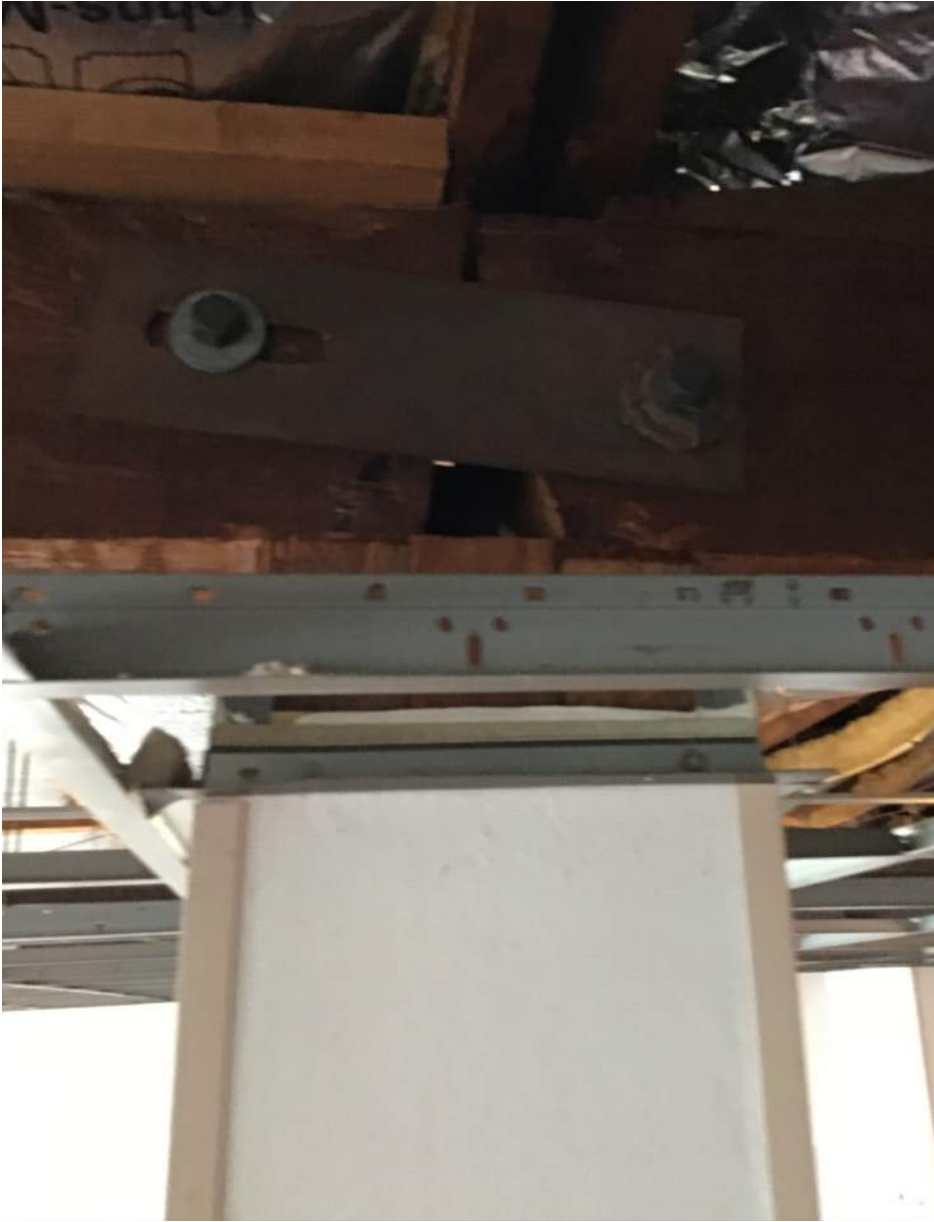
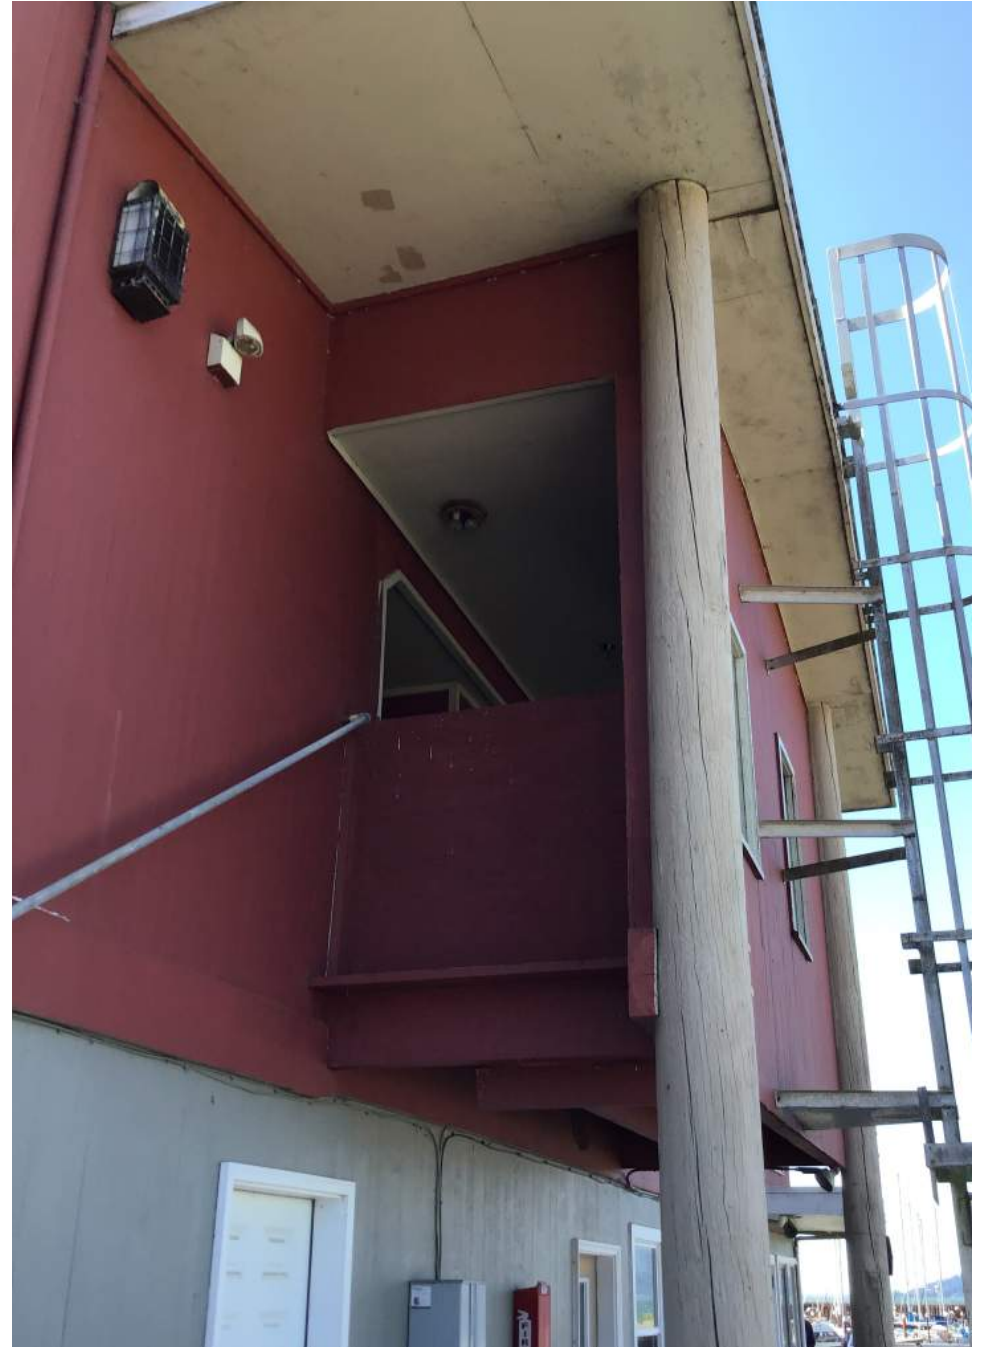
A: Typical primary beam connection, loose and potentially unsafe structural system.
B: Egress exit leading to no longer existing stairs causing a life and safety and unsafe egress issue.

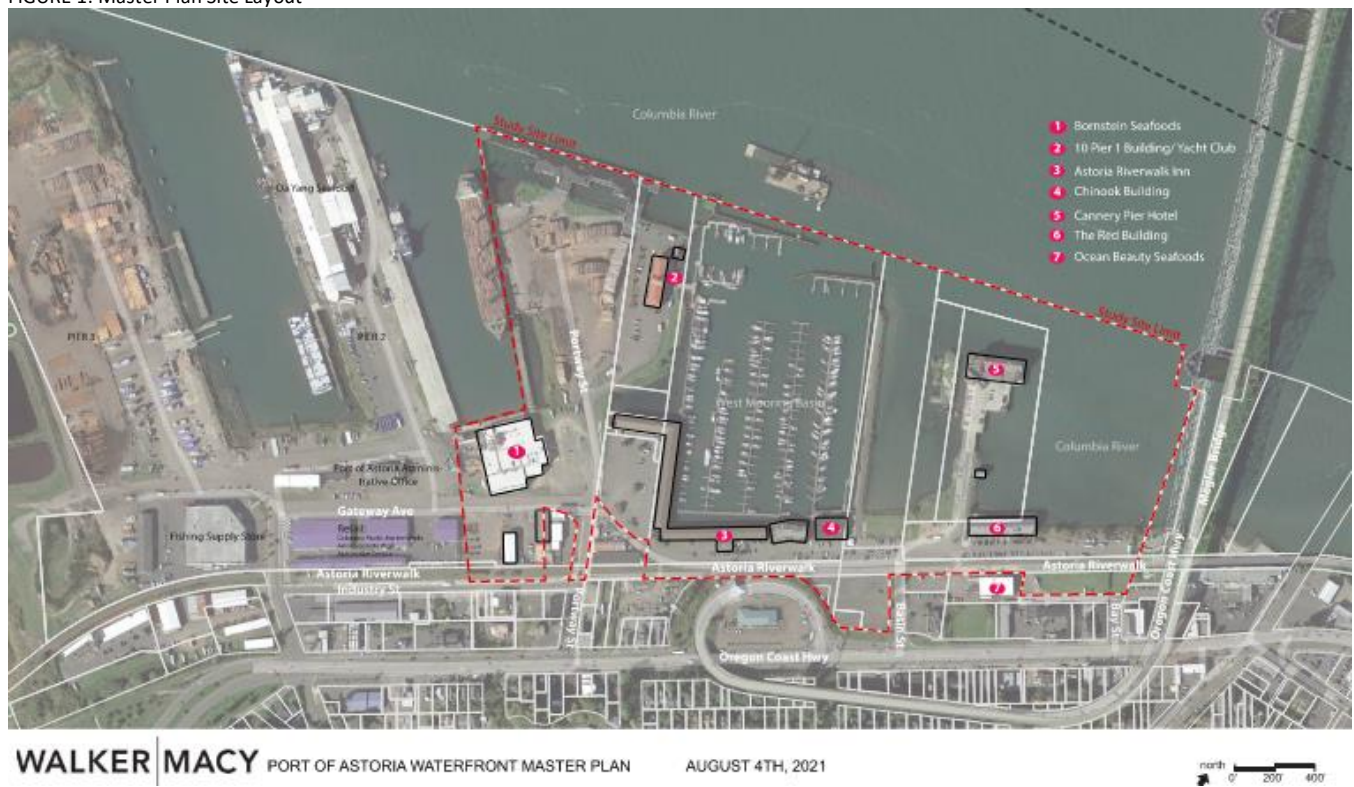
FIGURE 1: Master Plan Site Layout

The study area consists of a portion of the Astoria Riverwalk between Bay Street and Portway Street, north of the Oregon Coast Highway and west of the Astoria-Megler Bridge crossing the Columbia River. The study also consists of Pier 1 of the Port of Astoria and the accompanying marina infrastructure, including the west mooring basin. There are 6 existing buildings within the study area and multiple parking areas.

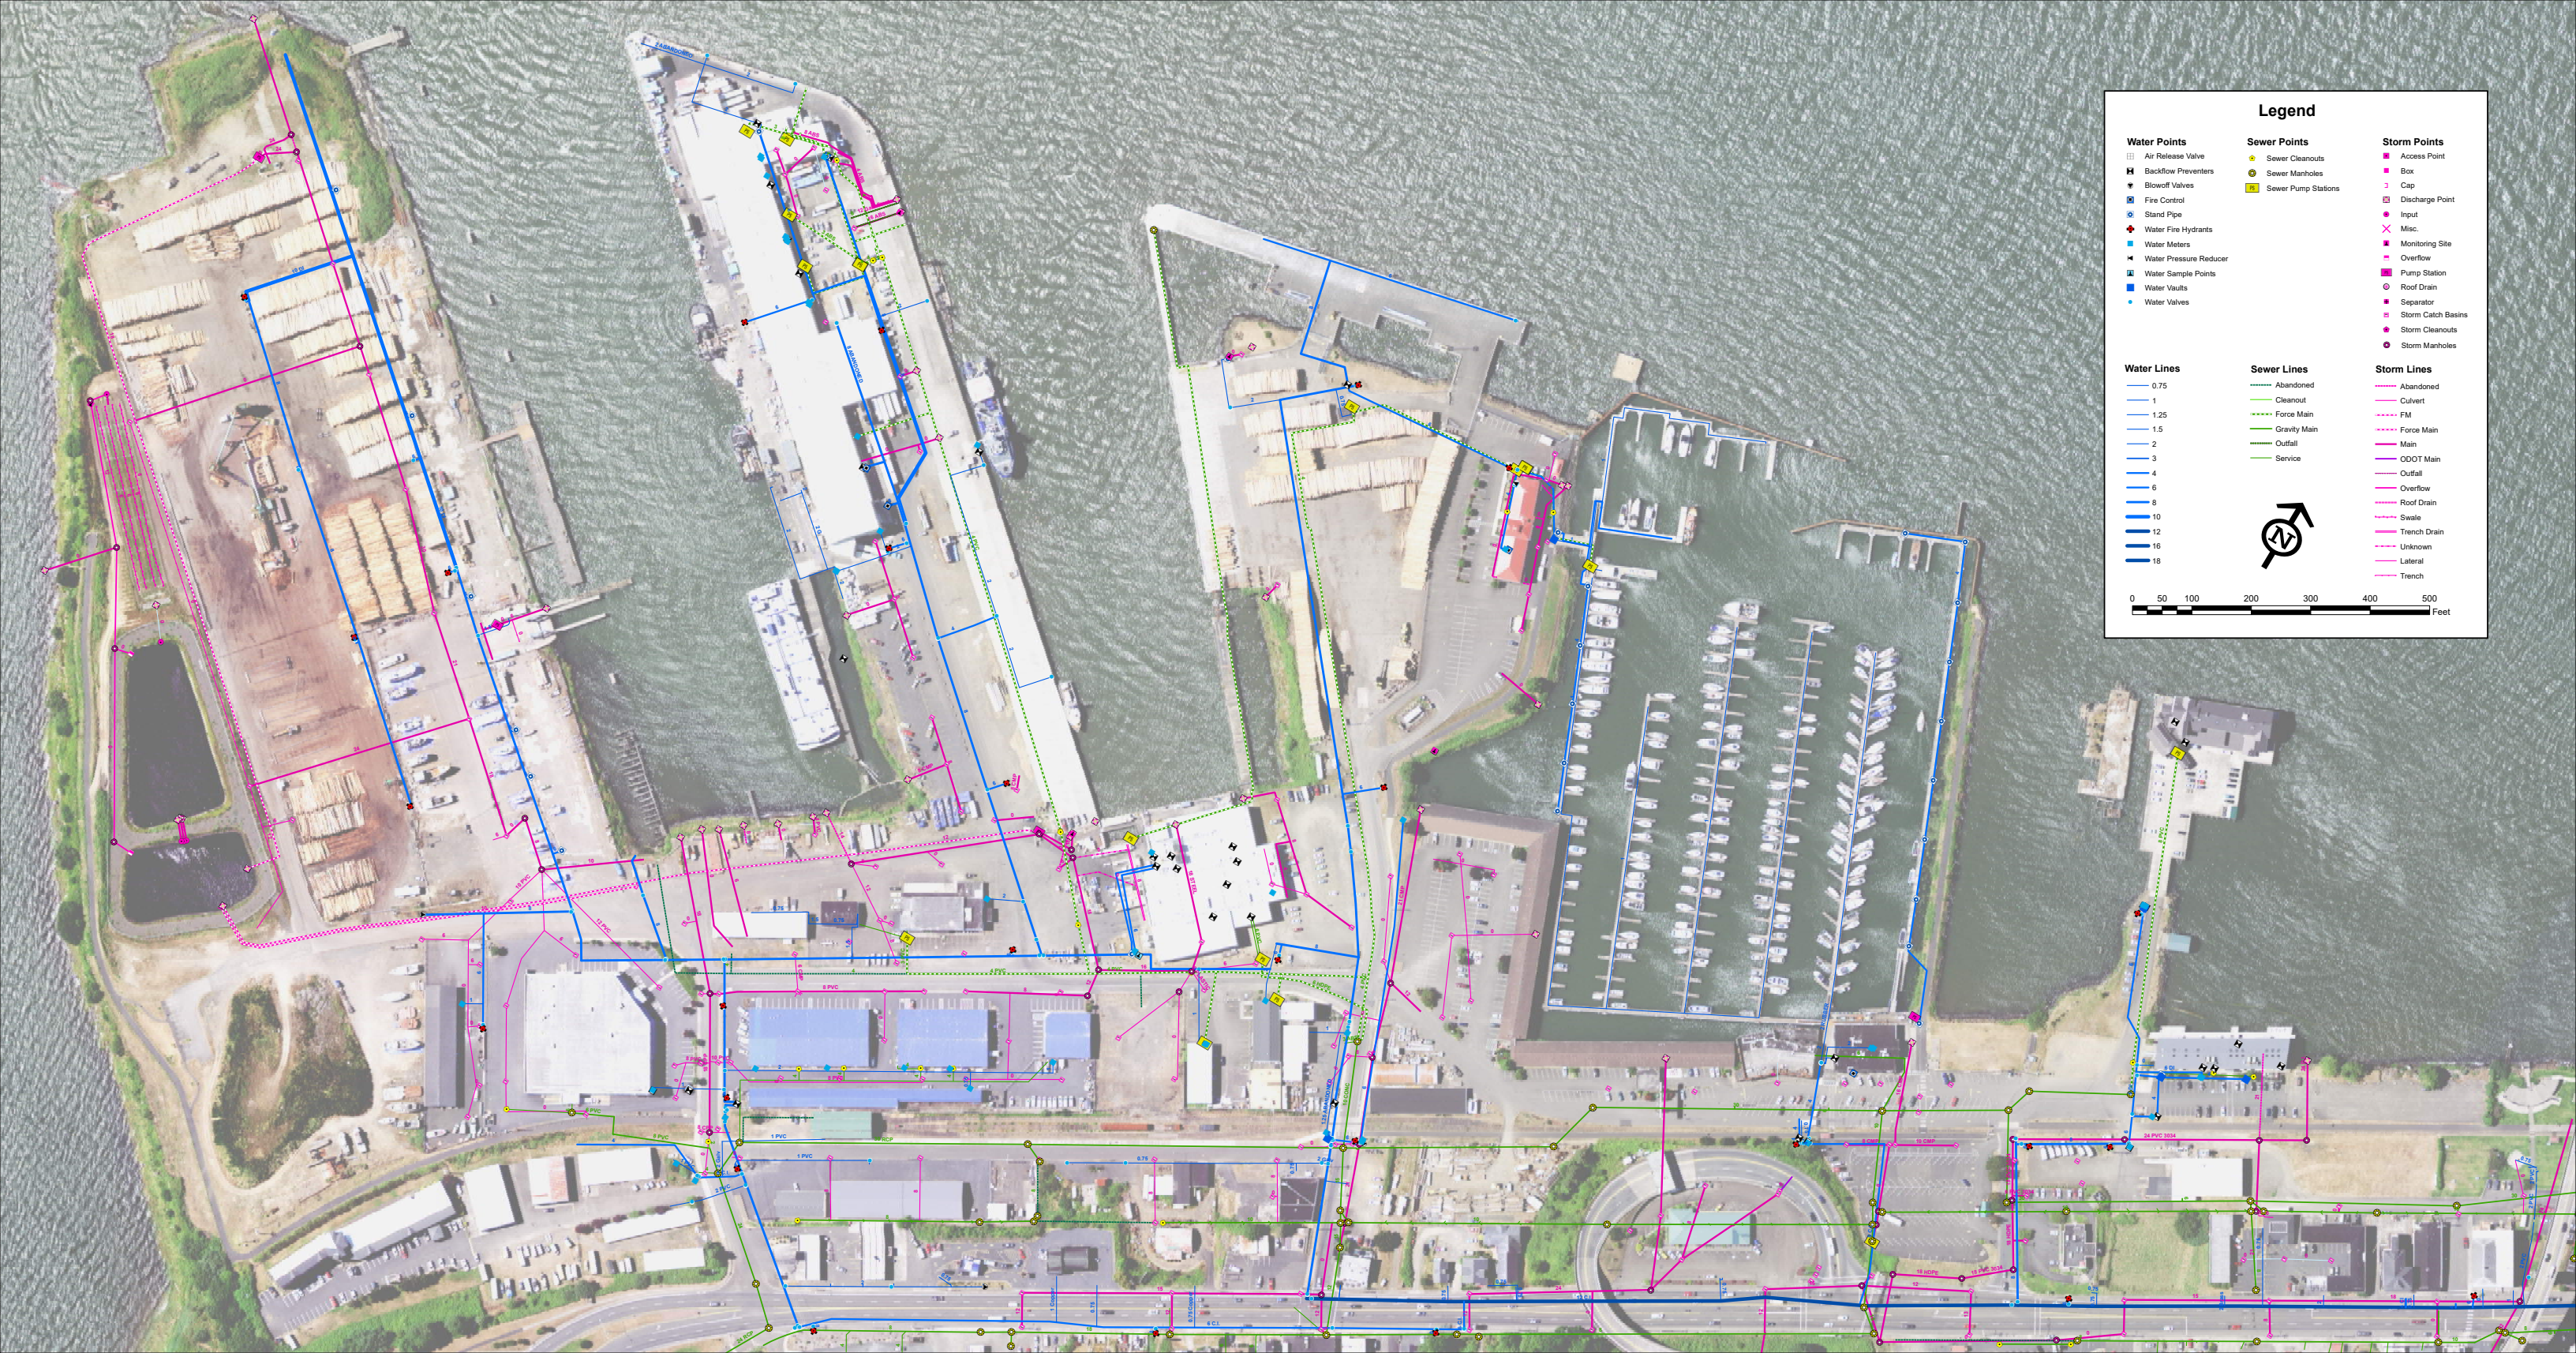
Legal Location: T08N R09W Sec7 SW
 State: OREGON
 County: CLATSOP
 City: ASTORIA
 Wallmap: ASTORIA

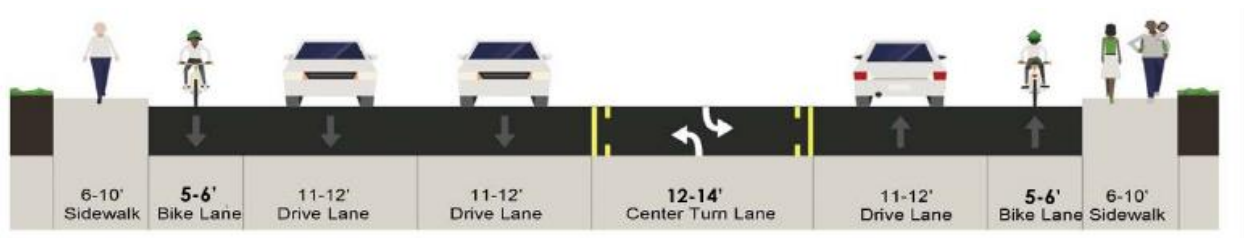
- Reconstruct W Marine Drive between Smith Point Roundabout and the Columbia Avenue/West Bond intersection to provide a four-lane cross-section with two westbound lanes, one eastbound lane, intermittent center two-way left turn lane, bicycle lanes, and sidewalks. Additional improvements include landscaping, ADA ramps at intersections, street lighting and transit stop amenities along the section where feasible.

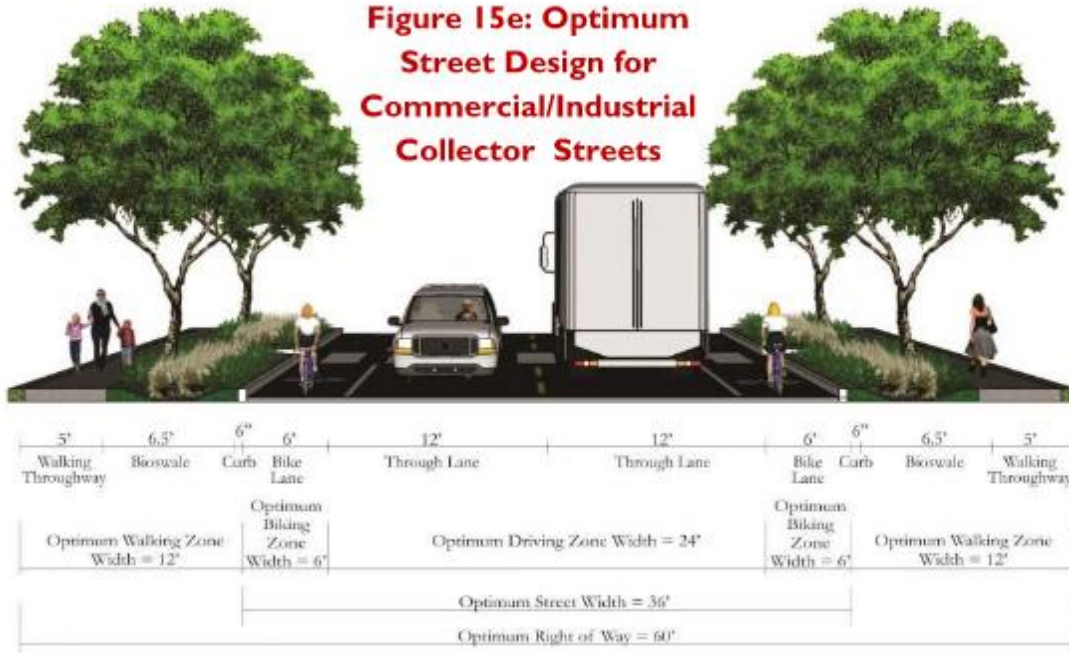
Figure 15e: Optimum Street Design for Commercial/Industrial Collector Streets

Portway Street would continue to serve as the primary connection to the Pier 1 and marina areas. With the Commercial/Industrial Collector section, Portway Street would benefit from providing two 12-foot travel lanes wide enough to accommodate truck demand and bike lanes to connect to the Astoria Riverwalk from W Marine Drive. The bike lanes also provide additional pavement width between the curbs to accommodate large vehicle turn movements when needed. On-street parking isn't a priority use for the facility, most of the fronting land uses has off-street parking available. Walking isn't a priority use for the facility. The five-foot sidewalks with landscaping street would accommodate anticipated pedestrian demand.

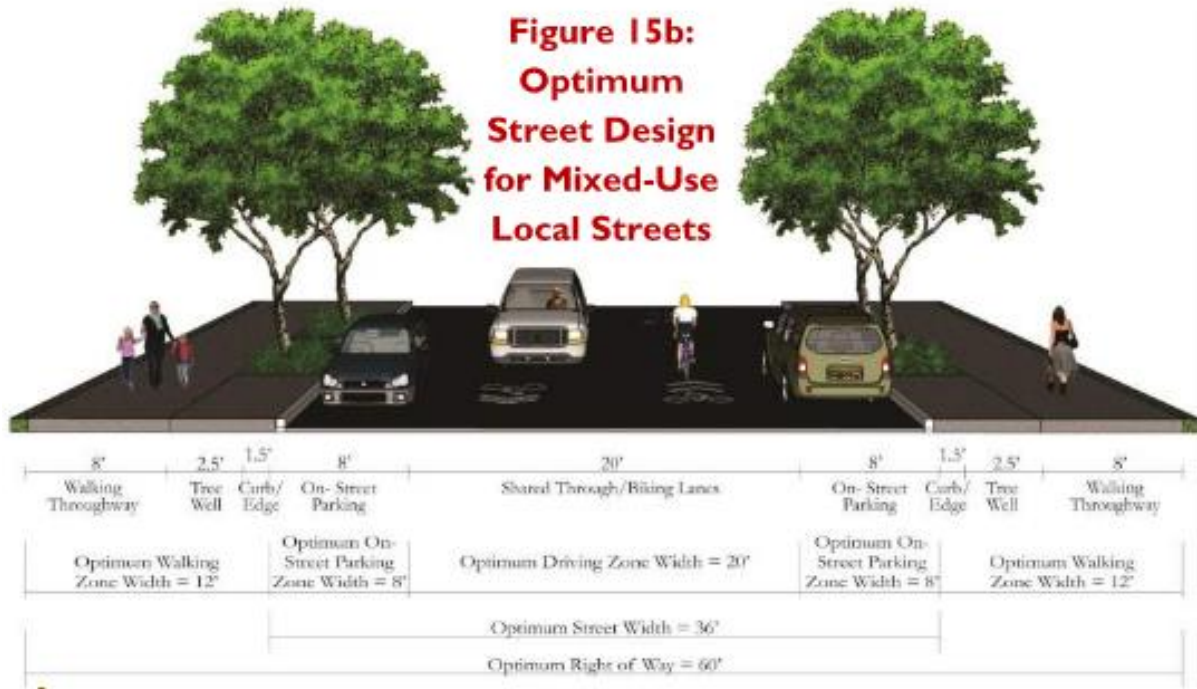
Basin Street and the planned extension of Bay Street would serve as the primary connection to the east portion of the Port site. The Mixed-Use Local Street section would provide an appropriate multimodal facility for the anticipated users. The center 20-foot wide section would accommodate both two-way vehicle traffic and bikes. The vehicle lane widths are appropriate to encourage lower speeds and the expected passenger vehicles (limited to no truck use). Mixing bikes and vehicles in the travel lanes is acceptable based on the estimated future vehicle volumes and speeds. On-street parking on both sides of the facilities would provide much needed parking supply for the adjacent land uses. Walking is a priority for the facility due to the connection to the Uniontown commercial area on w Marine Drive. The anticipated demand would be accommodated with 10.5-foot wide sidewalks with tree wells.
