**A PHASE I  
ENVIRONMENTAL SITE ASSESSMENT**

1.48-Acre Safeway/American Legion Property  
1153 Duane Street and 1132 Exchange Street  
Astoria, Oregon

January 17, 2003

Hahn and Associates, Inc.  
Portland, Oregon

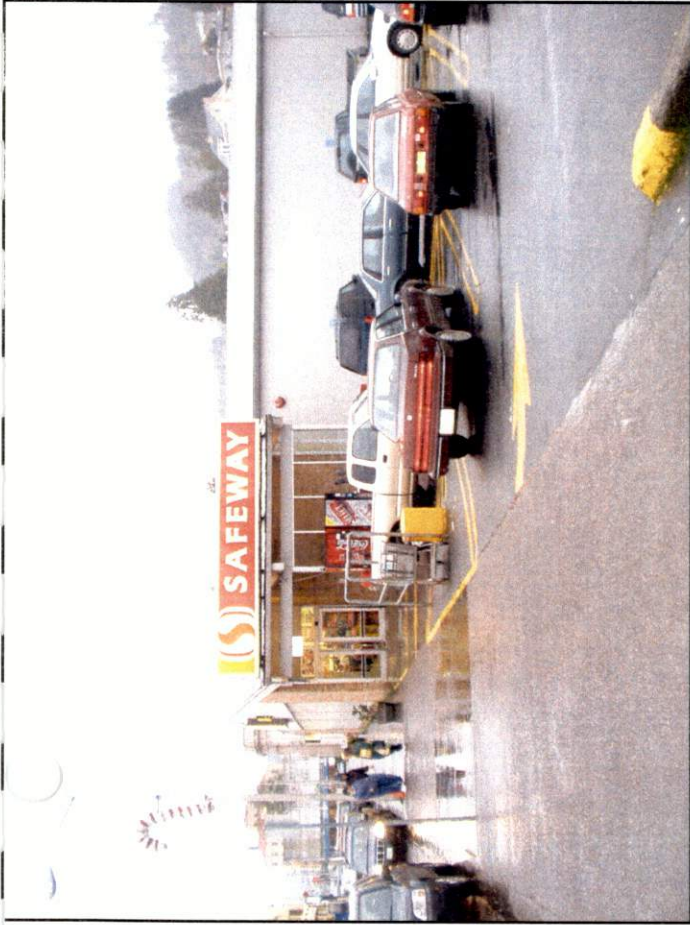
At the time of the site investigation, the subject property was developed with an approximately 17,236-square foot Safeway grocery store structure (Photograph 1) and a partially-adjoining two-story American Legion building (Photograph 2), both of which included basements. The remainder of the property consisted of asphalt-paved parking space. The property's western parking lot was situated directly on fill material. The property's eastern parking lot, as well as the sidewalks adjoining the property, were elevated by pillars situated on concrete footings in fill sand below the development.

Photograph 1: View of the Safeway store on the subject property, facing toward the east from the property's northwestern corner (January 3, 2003).

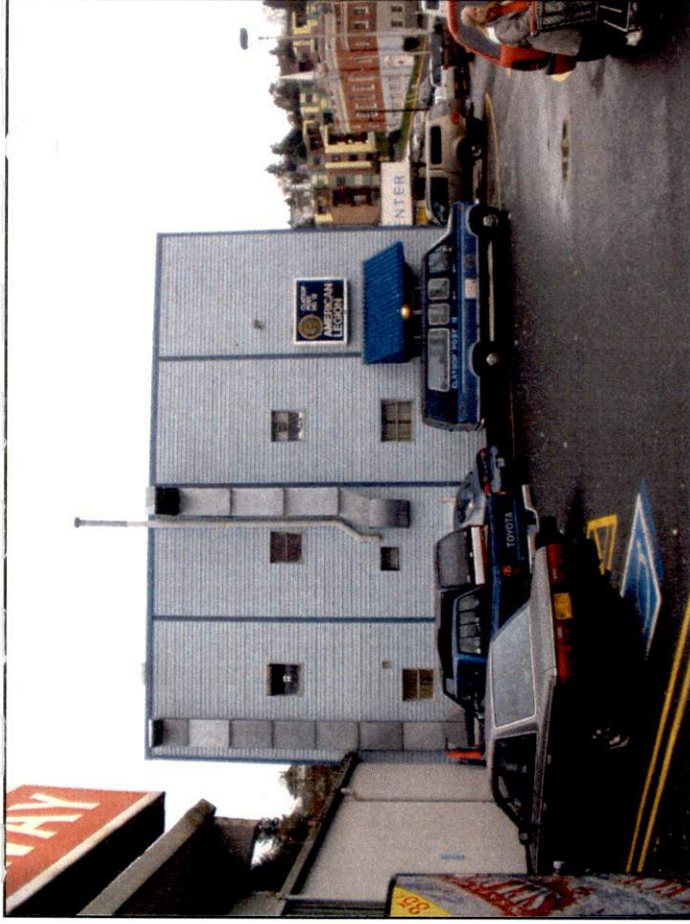
Photograph 2: View of the American Legion building on the property, facing toward the south from the property's northern perimeter (January 3, 2002).
