MEMORANDUM

GRI Project No.: 6580-A

Re: Preliminary Geotechnical Assessment
Heritage Square Development
12th and Duane Street
Astoria, Oregon

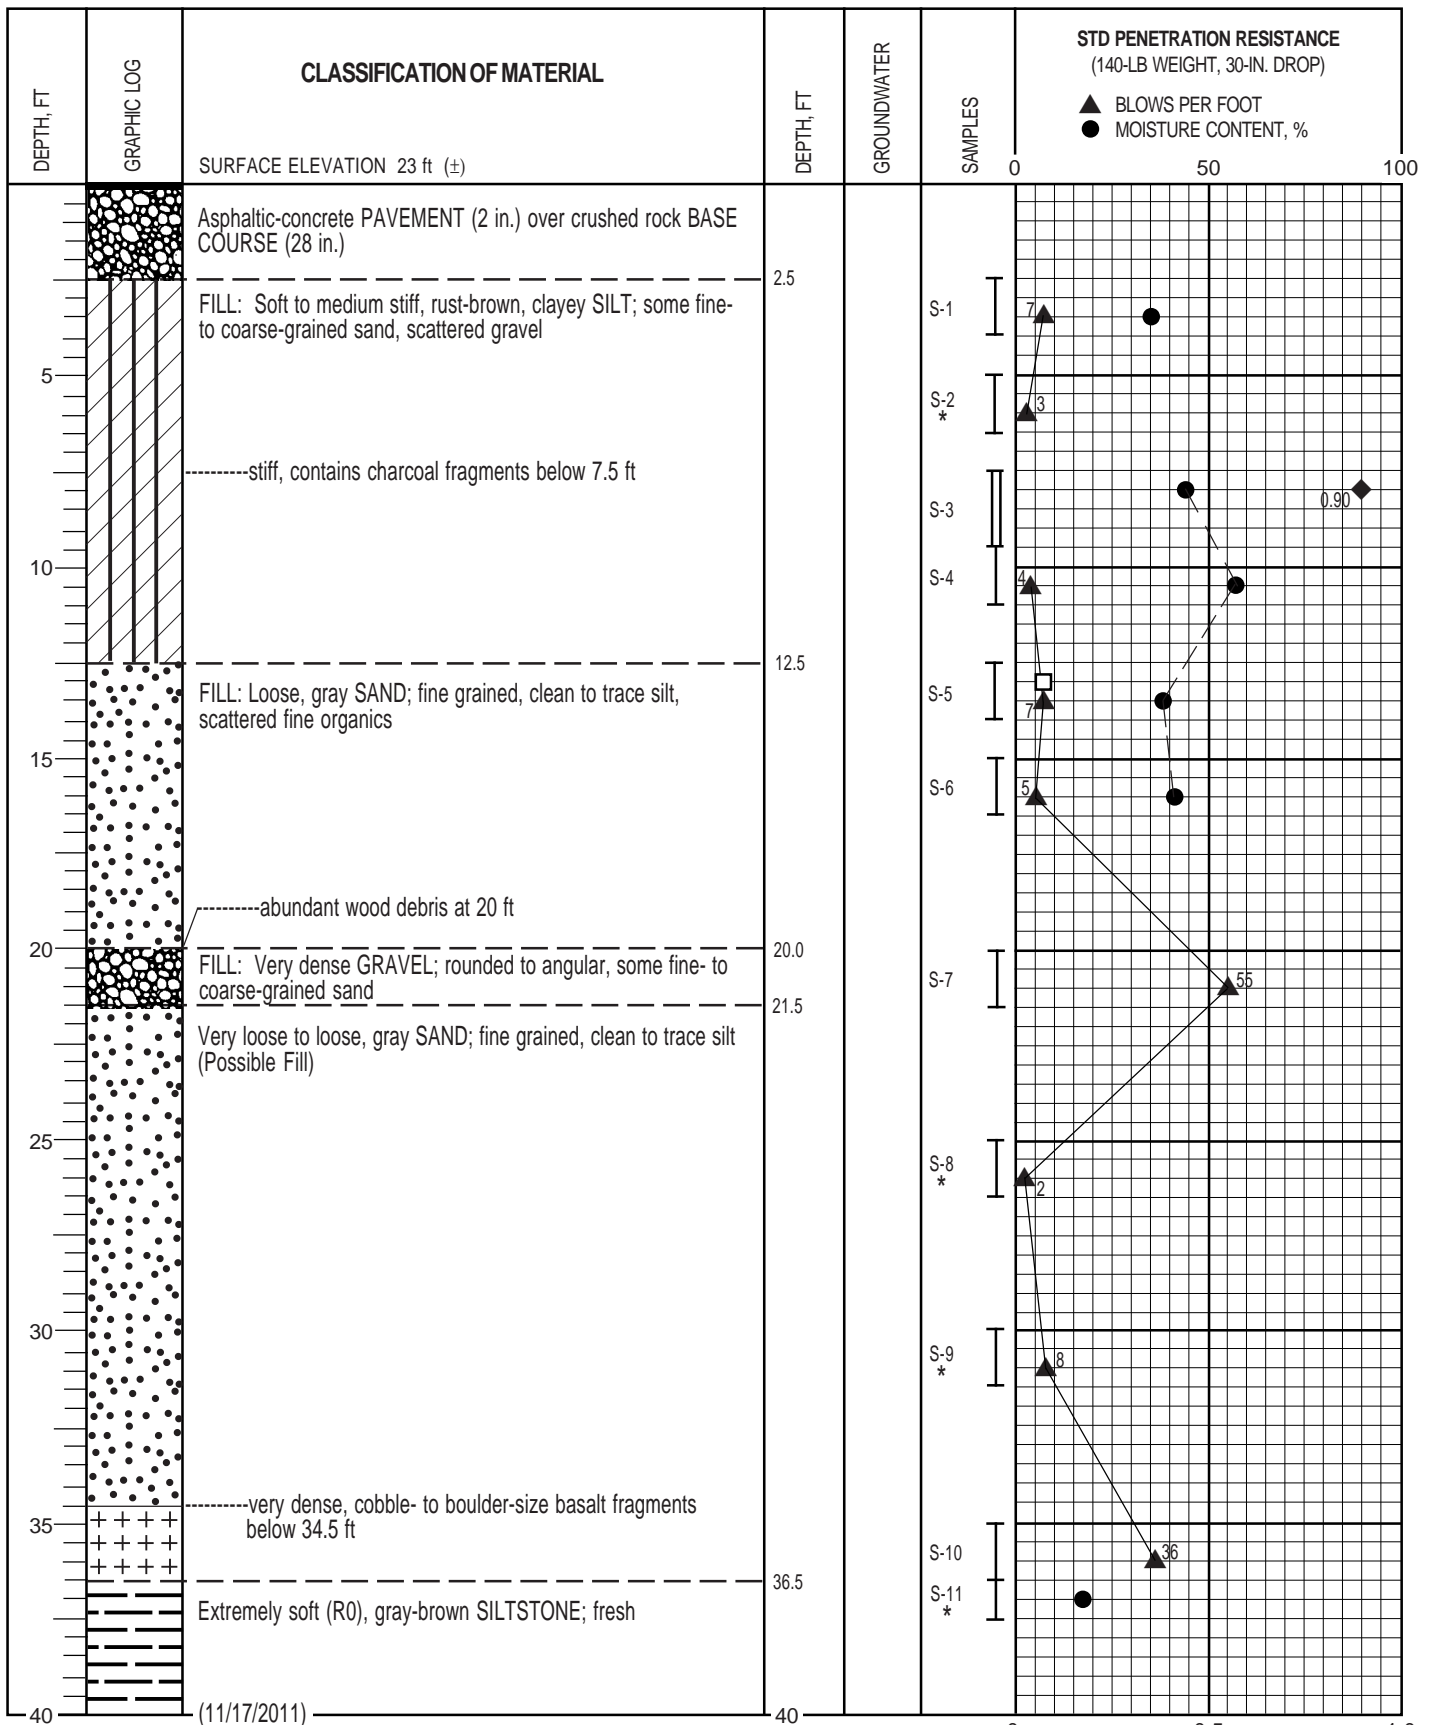
BORING B-3

- I 2-IN.-OD SPLIT-SPOON SAMPLER
- II 3-IN.-OD THIN-WALLED SAMPLER
- G GRAB SAMPLE OF DRILL CUTTINGS
- NX CORE RUN
- SLOTTED PVC PIPE
- ▼ Water Level (date)
- ◆ TORVANE SHEAR STRENGTH, TSF
- PERCENT PASSING NO. 200 SIEVE (WASHED)
- * NO RECOVERY
- Liquid Limit
- Moisture Content
- Plastic Limit
